The following is the final report associated with "Harness Testing Technical Proposal", submitted on March 3, 2008 to InterConnect Wiring, L.P. Attn. Mr. John Ashour.

Lectromec Job Order JOInter/N303  
July 29, 2008  
Lectromechanical Design Company  
(A Division of Lights Fantastic Inc.)  
45000 Underwood Lane  
Sterling (Dulles), Virginia 20166-2305

**Executive Summary:**

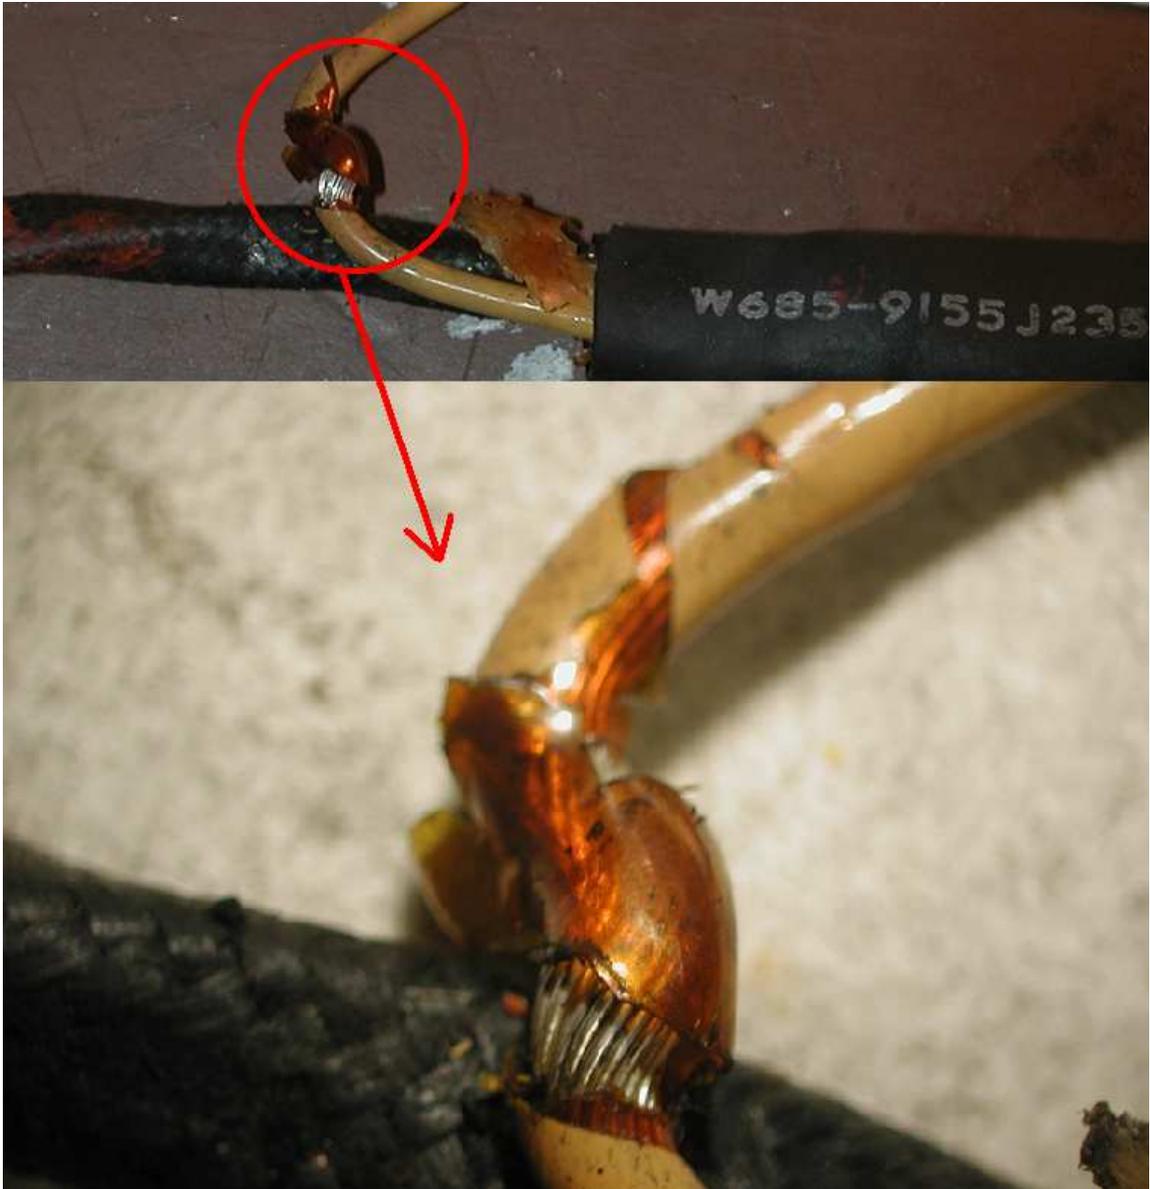
**Figure 1. Harness H16DW685-9155. Breach of wire insulation down to the conductor.**

Figure 1 and Figure 2 show examples of the types of failures found with the DelTest. In the case of the failure found in Figure 2, it shows that there was an additional breach in the same wire less than one centimeter from the wire failure seen in.

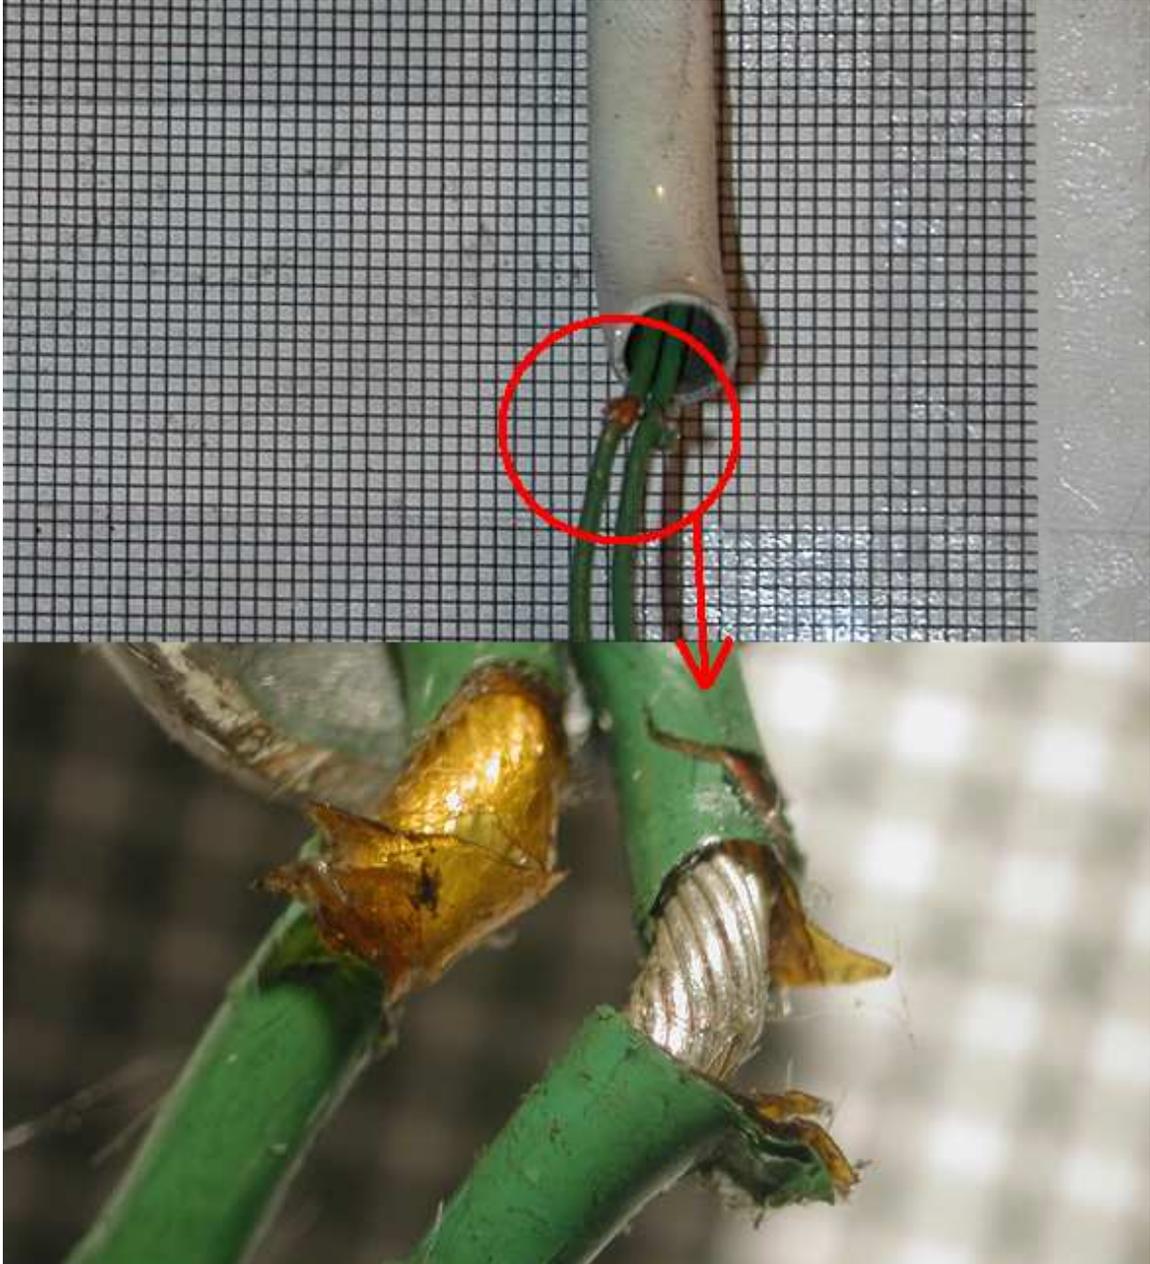
**Figure 2. Harness H16DW696, two wires coming out of a conduit with breaks in the insulation at the same location. The grid size in the figures is 1mm x 1mm.**

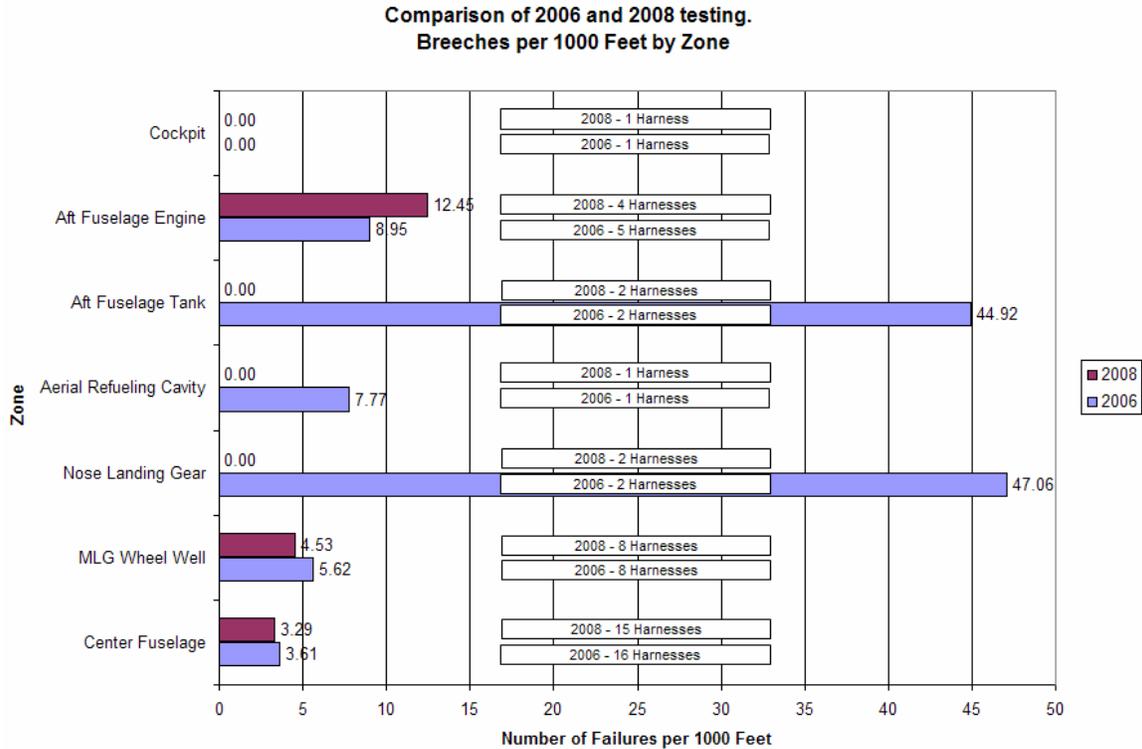
Figure 3. Comparison of DelTest 2006 and 2008. Breeches per 1000 Feet reported by zone.

The greatest variation seen between the 2006 and 2008 testing was in the Nose Landing Gear, Aerial Refueling Cavity and Aft Fuselage Tank. No wire breaches were found in any of these harnesses, whereas failures were found in previous testing (Table 2 and Figure 3). Given the limited number of wires in these harnesses, failure of any wire would show a significantly higher rate of failure (e.g. the Nose Landing Gear zone in the 2006 tests had only two failures, but, because of only 42feet of wire in the harnesses, exceptionally high rate was found). In comparing the results of the two zones from which most of the harnesses came (the center fuselage and main landing gear wheel well), the failure rates are comparable, though in both zones, the harnesses from 2008 testing showed a reduced failure rate. The only zone to show an increase in the number

of failures was the Aft Fuselage Engine Area which showed an increase from 9.0 failures/1000ft in 2006 to 12.5 failures/1000ft.

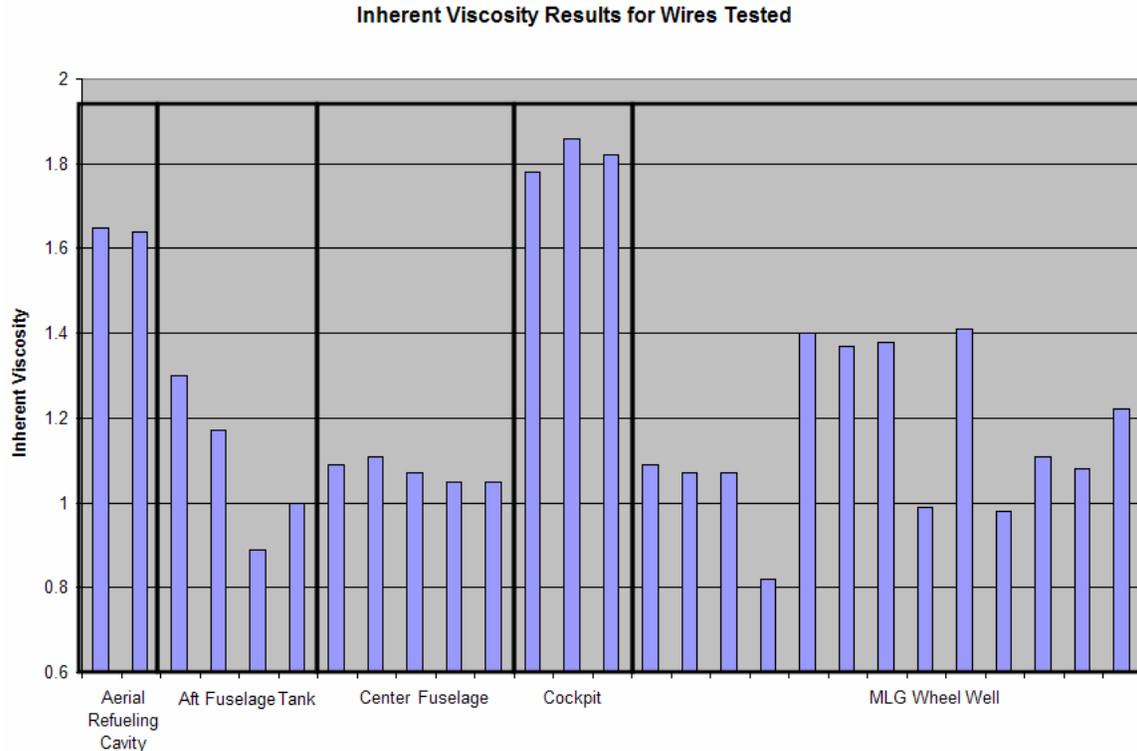
This is not unexpected, since the wheel well zone of an aircraft experiences a greater environmental exposure than other locations. The exception to this general observation is with harness 782 and one wire in harness 783.

The findings for the Central Fuselage also imply that these wires are close to the end of their lifetime.

The wires in harnesses 698 and 1523, the Aerial refueling cavity and cockpit, respectively, have values that indicate that there is not any immediate concern for these wires. The values for the cockpit are not surprising, since this zone probably experiences the least environmental challenge in the aircraft. However, this does not explain why there were relatively low values for the wires tested in 2006 from this location. There does not appear to be any trend for the wires located in the aft fuselage tank.

**Figure 4. Inherent Viscosity results broken down by zone.**

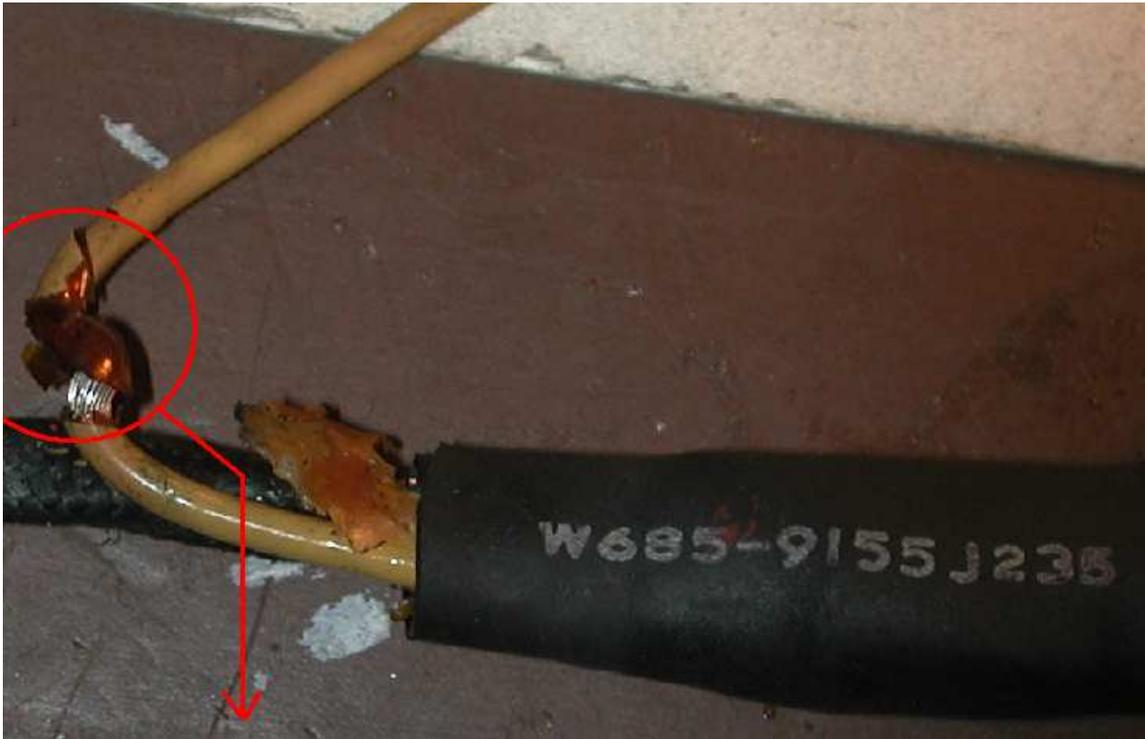
**Figure C-1: Photo: Harness: H16DW685-23. Conductor exposed**

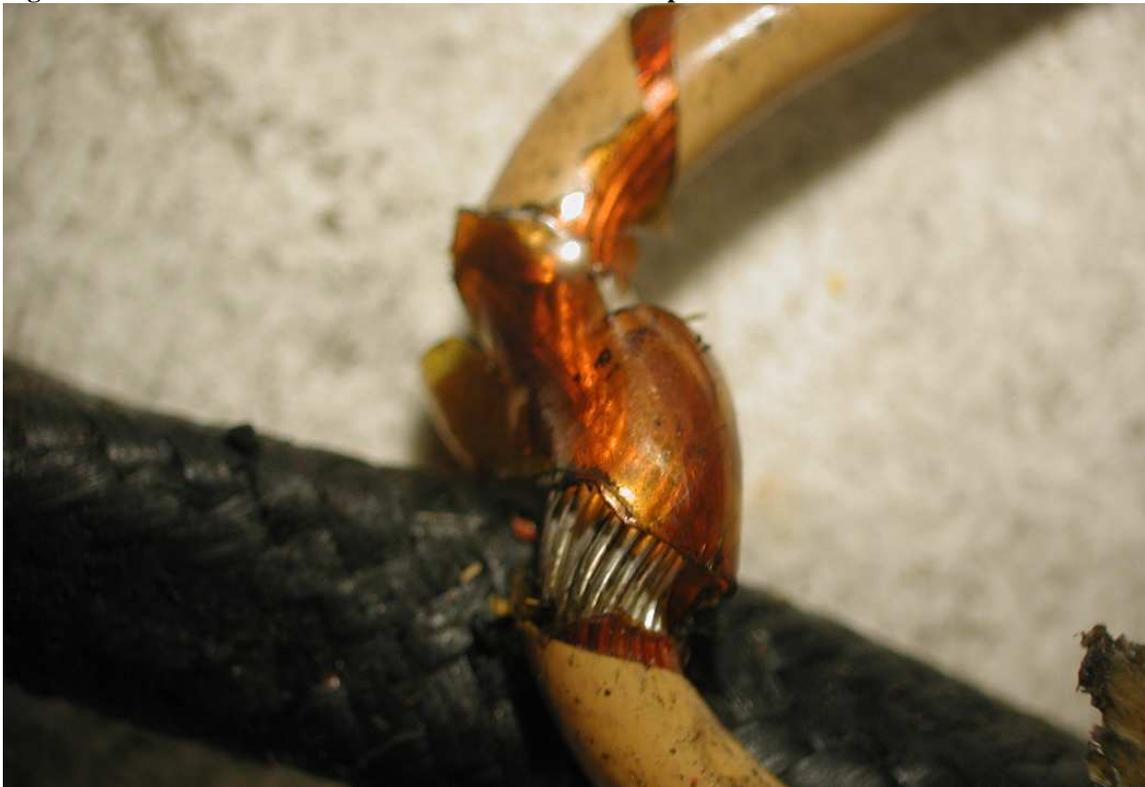
**Figure C-2: Photo: Harness: H16DW685-23: Photo taken under higher magnification. Conductor exposed.**

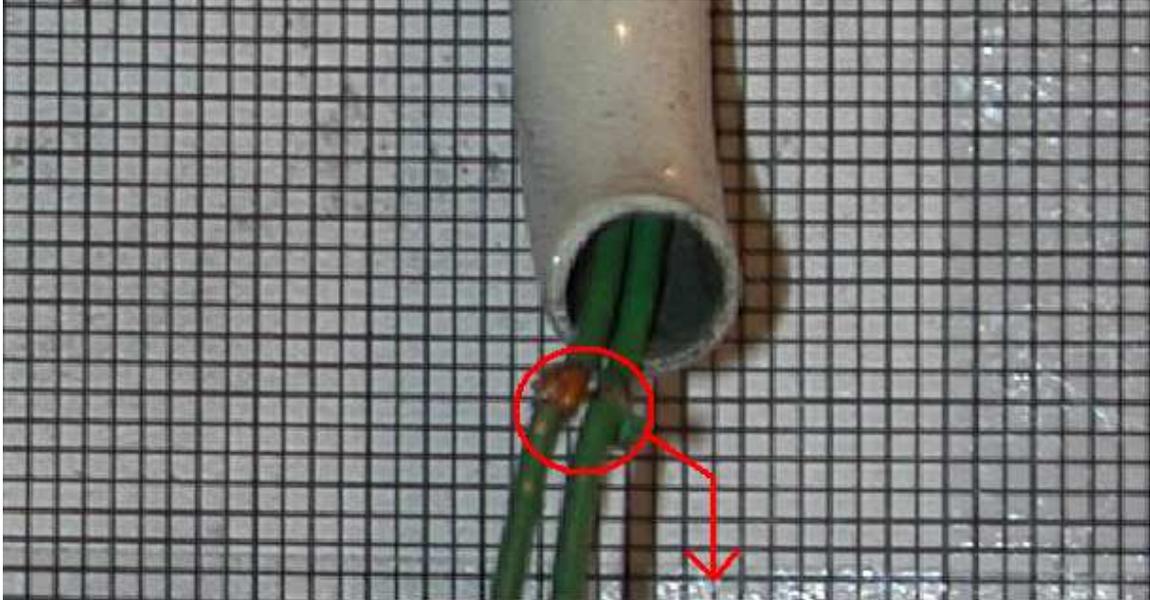
**Figure C-3: Harness H16DW696-21 (a). Background grid is 1mm by 1mm. Wire 2 as seen with minimal magnification.**

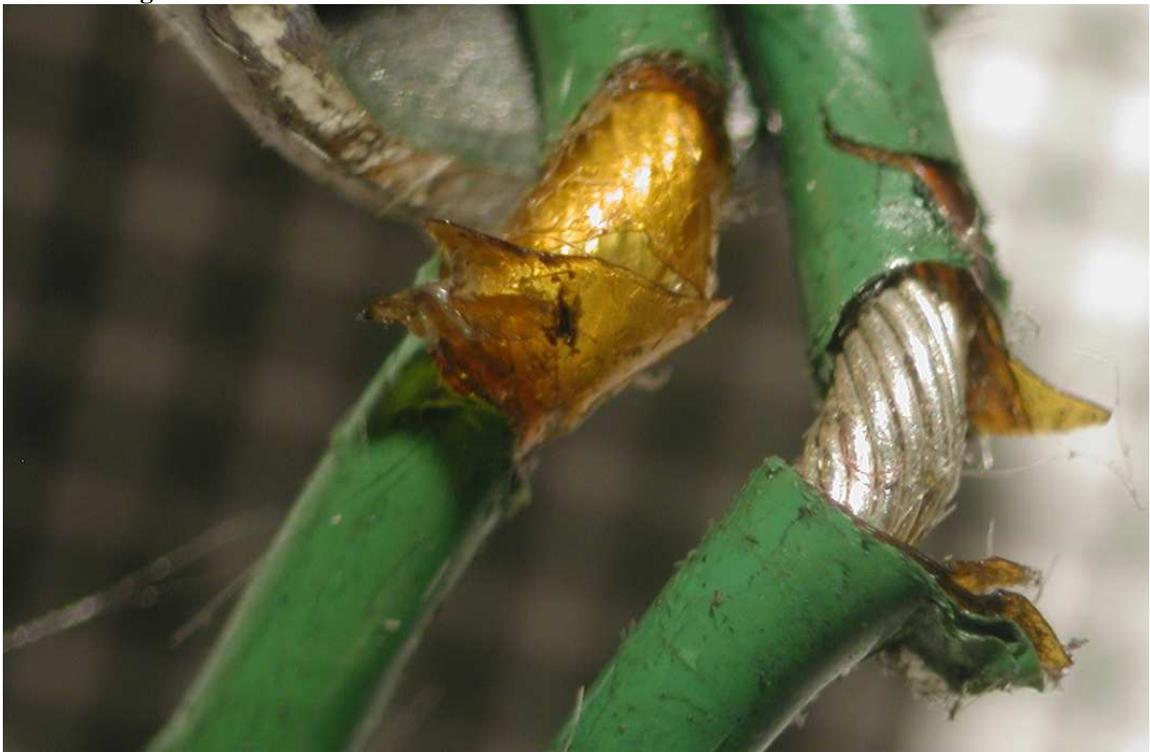
**Figure C-4: Harness H16DW606-21 (a). Wire 2 has exposed conductor. Damage to the insulation of wire 1.**

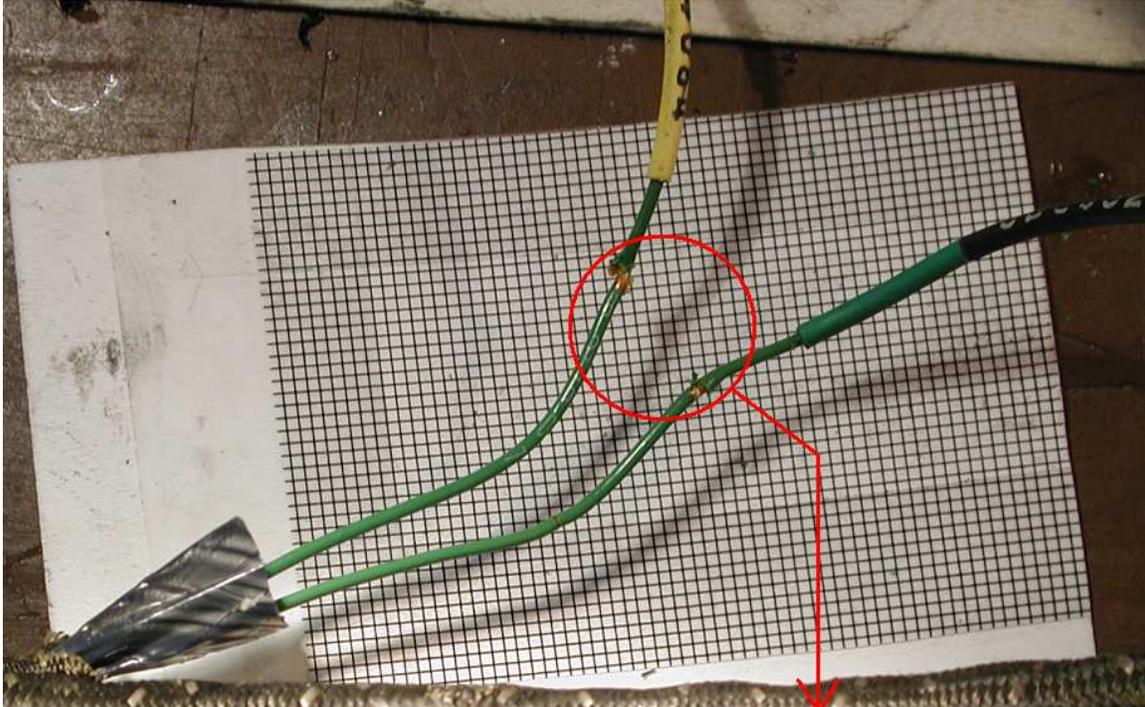
**Figure C-5: H16DW651- wires 54 and 55. Background grid is 1mm long by 1mm wide. Wires 54 and 55 as seen with minimal magnification. Insulation breached to the conductor towards the GD6552 end.**

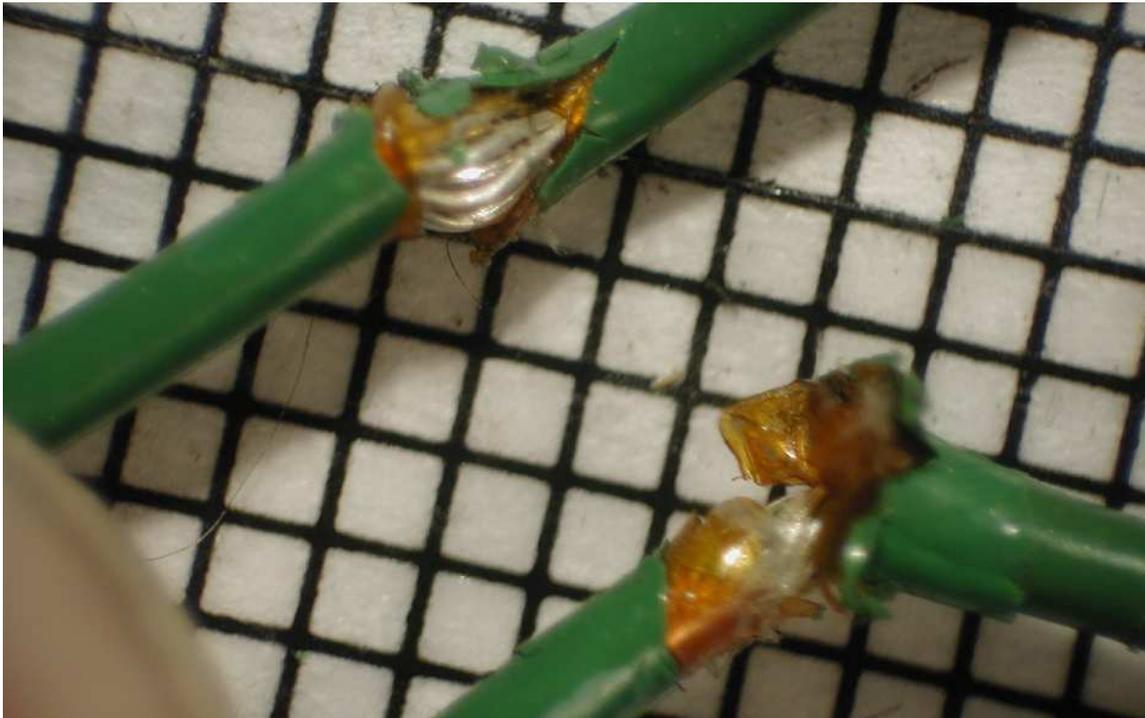
**Figure C-6: Photo: H16DW651-wires 54 and 55. Background grid is 1mm long by 1mm wide. Wires 54(top) and 55(bottom) as seen under a microscope. Conductor Exposed.**

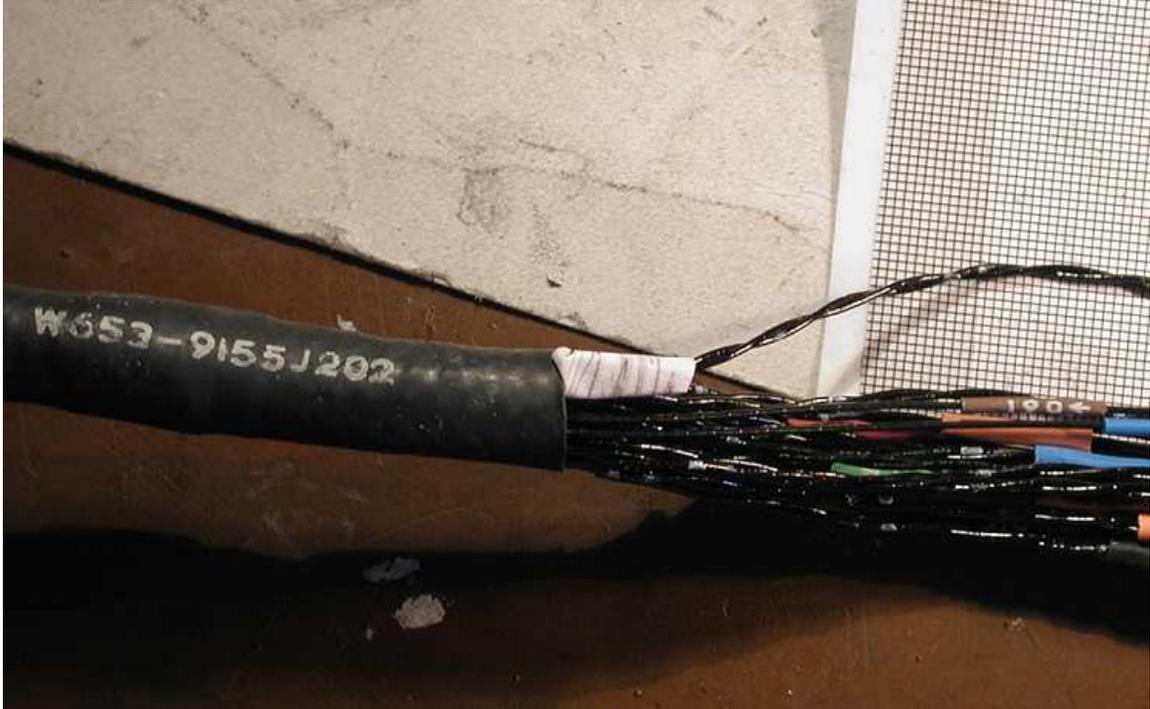
Figure C-7: Harness: H16DW653, wire224-1. Break in 24 gauge wire. Background grid scale 1mm x 1mm.

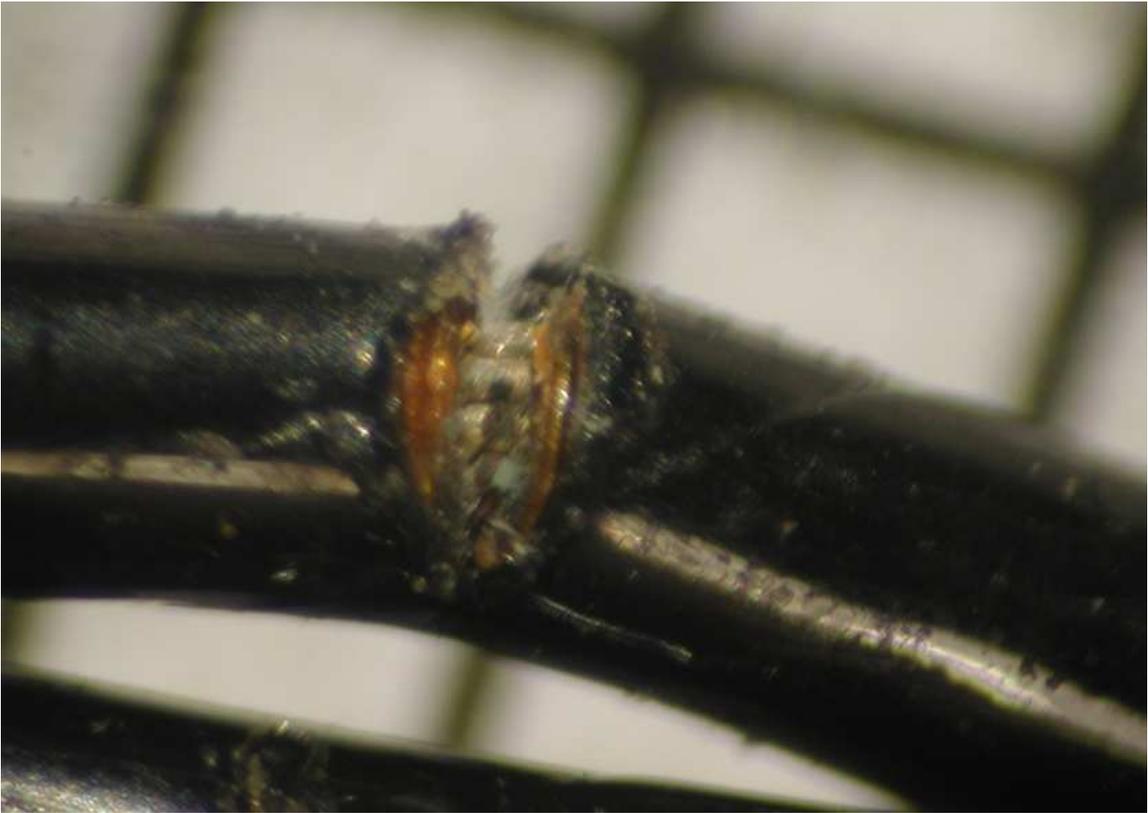
Figure C-8: Harness: H16DW653, wire224-1. Close-up photo of Figure C-7. Background grid scale 1mm x 1mm.

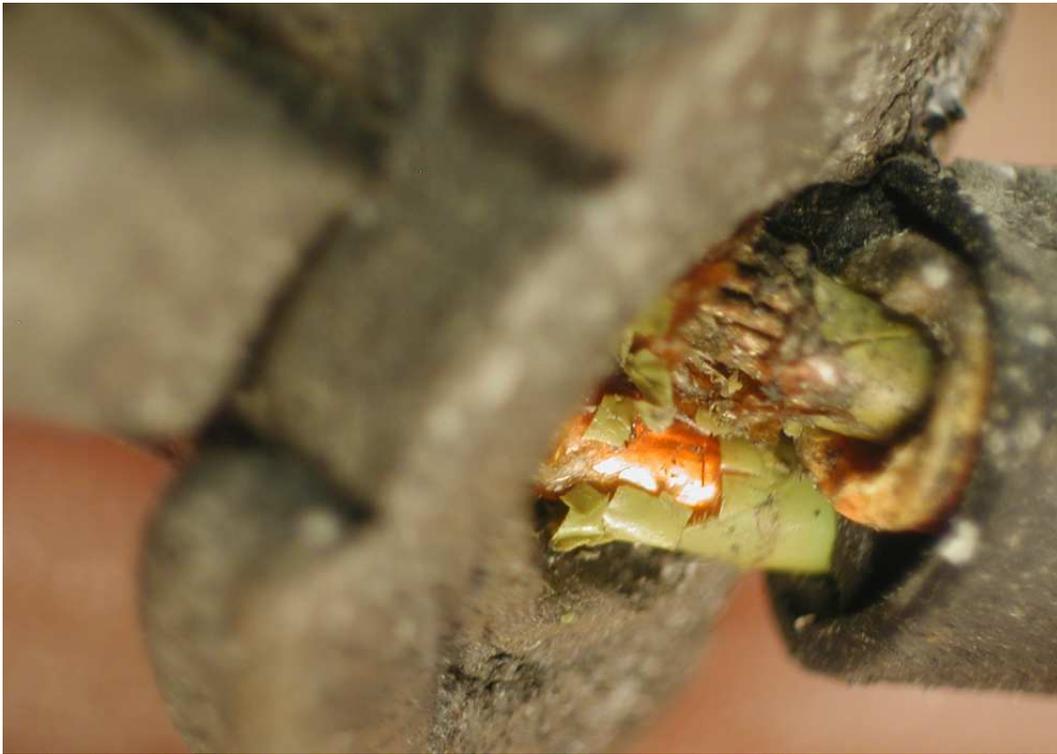
**Figure C-9: Harness: H16DW693-21. Wires coming out of a conduit with multiple breaches to conductor.**

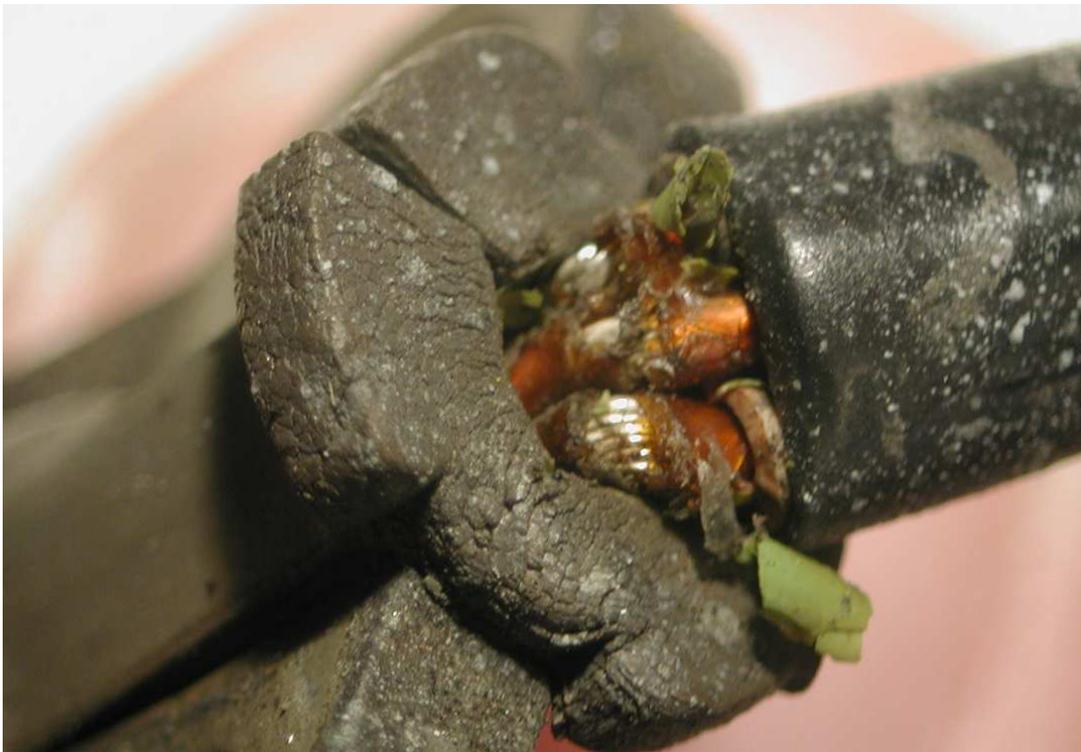
**Figure C-10: Harness: H16DW693-21. Same as Figure C-9.**

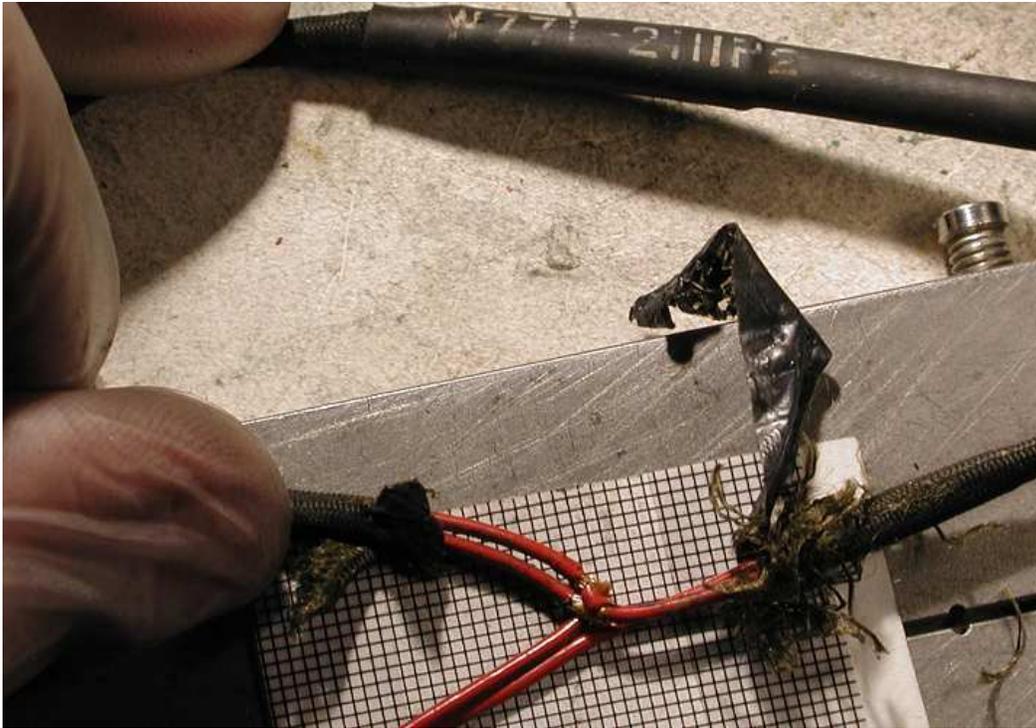
**Figure C-11. Harness H16DW771, wire numbers 15 and 16. Insulation breach found at break intersection with wire bundle. Background grid scale 1mm x 1mm.**

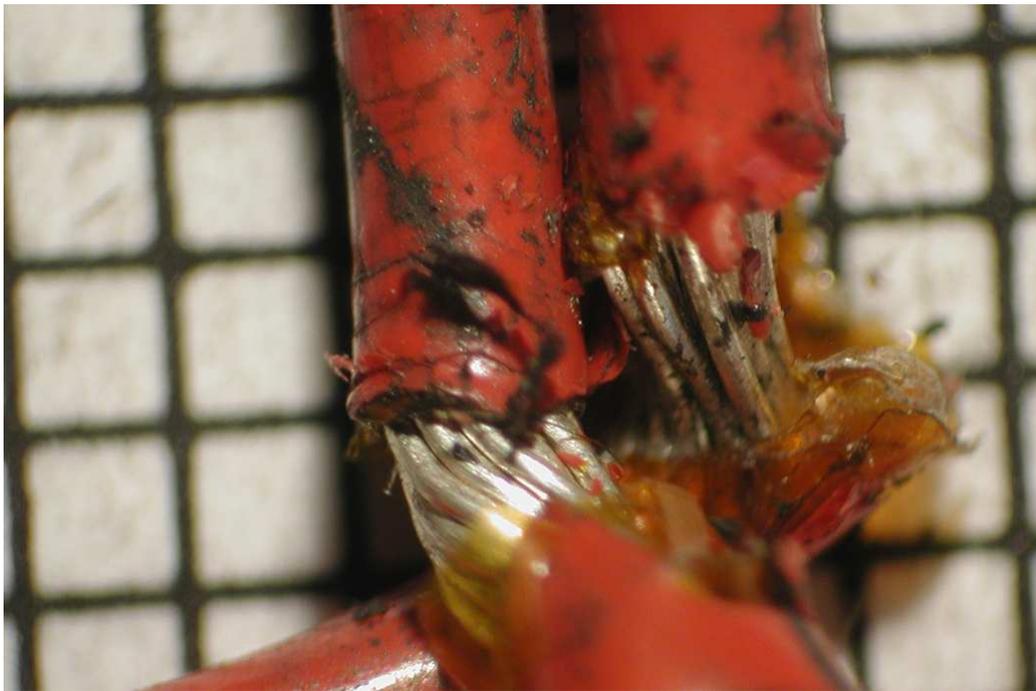
**Figure C-12. Harness H16DW771, wire numbers 15 and 16. Close-up photo of Figure C-11. Background grid scale 1mm x 1mm.**
