The following is the final report associated with "Harness Testing Technical Proposal", submitted on March 3, 2008 to InterConnect Wiring, L.P. Attn. Mr. John Ashour.

Lectromec Job Order JOInter/N303
July 29, 2008
Lectromechanical Design Company
(A Division of Lights Fantastic Inc.)
45000 Underwood Lane
Sterling (Dulles), Virginia 20166-2305

Executive Summary:

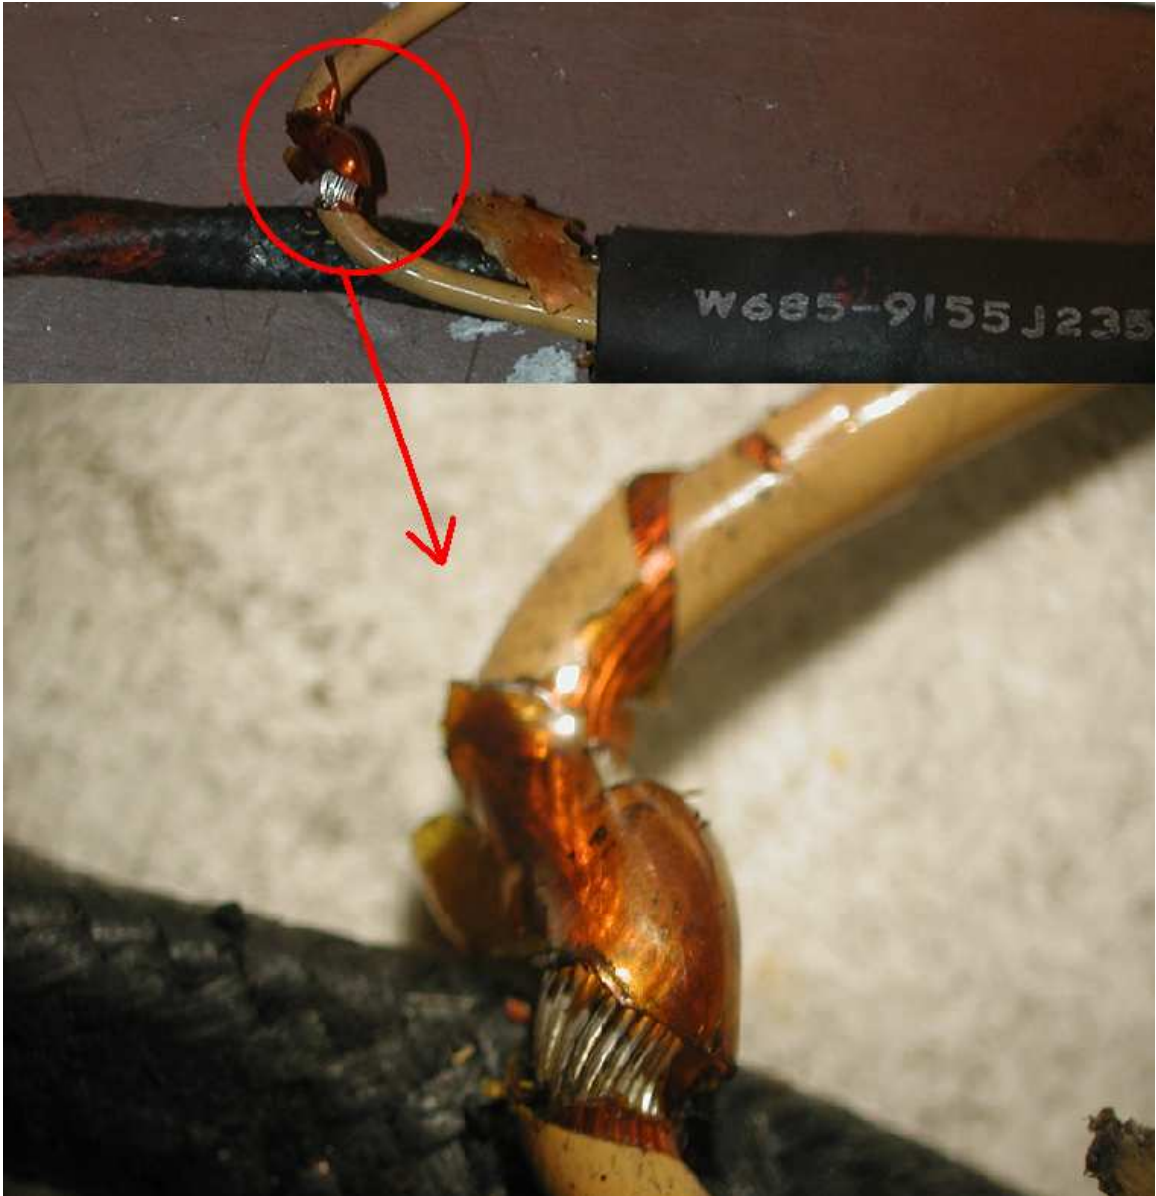
Figure 1. Harness H16DW685-9155. Breach of wire insulation down to the conductor.

Figure 1 and Figure 2 show examples of the types of failures found with the DelTest. In the case of the failure found in Figure 2, it shows that there was an additional breach in the same wire less than one centimeter from the wire failure seen in.

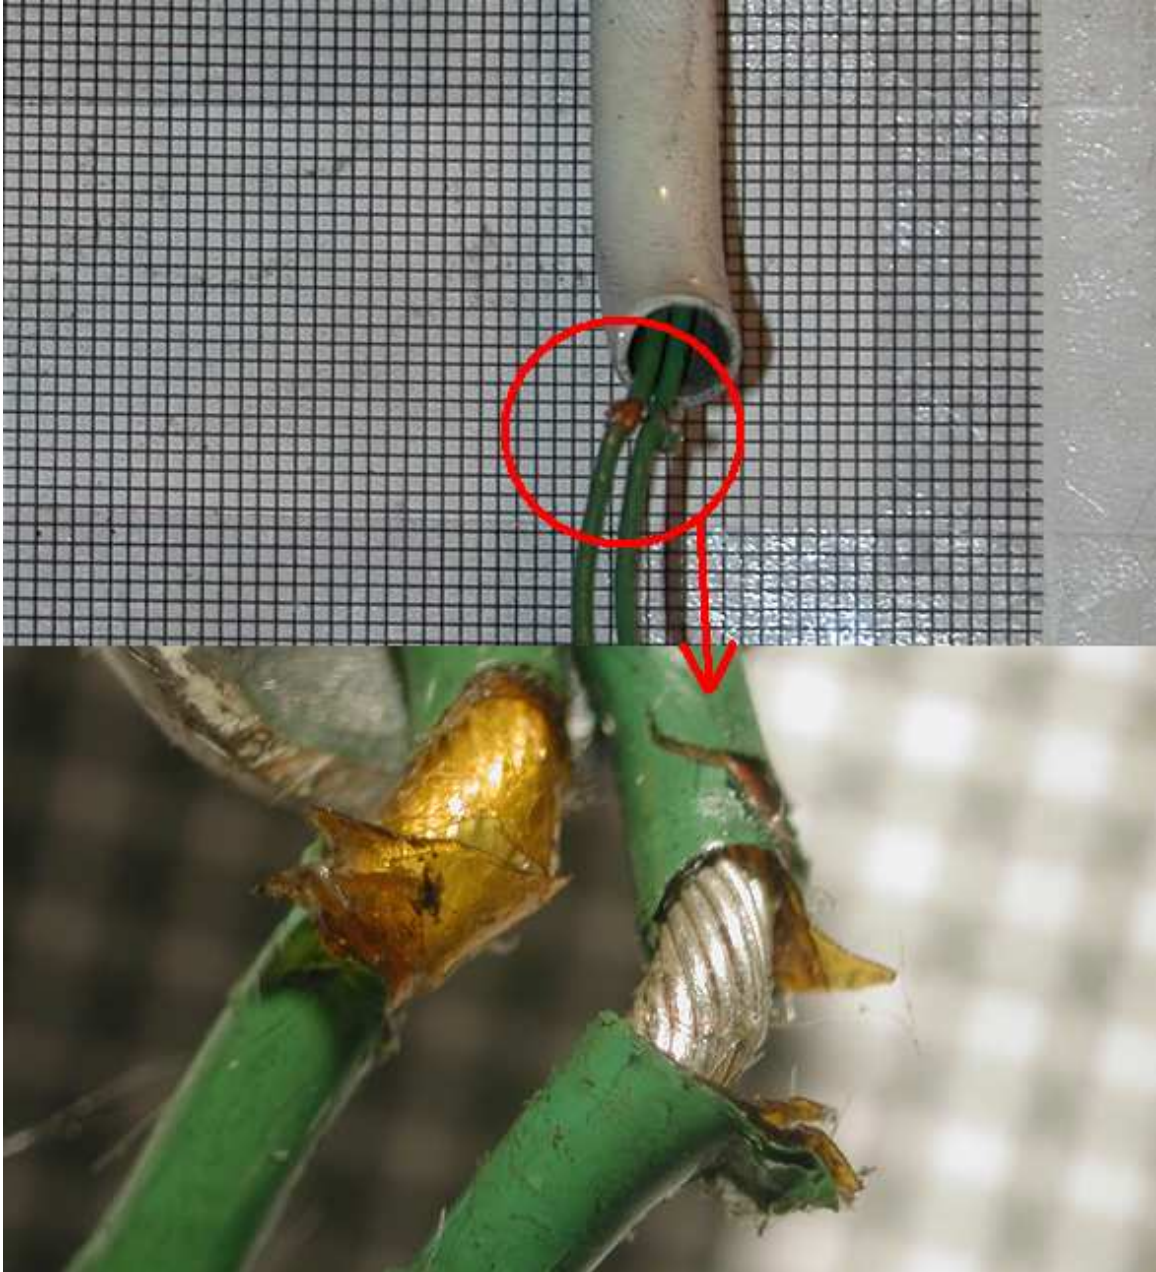
Figure 2. Harness H16DW696, two wires coming out of a conduit with breaks in the insulation at the same location. The grid size in the figures is 1mm x 1mm.

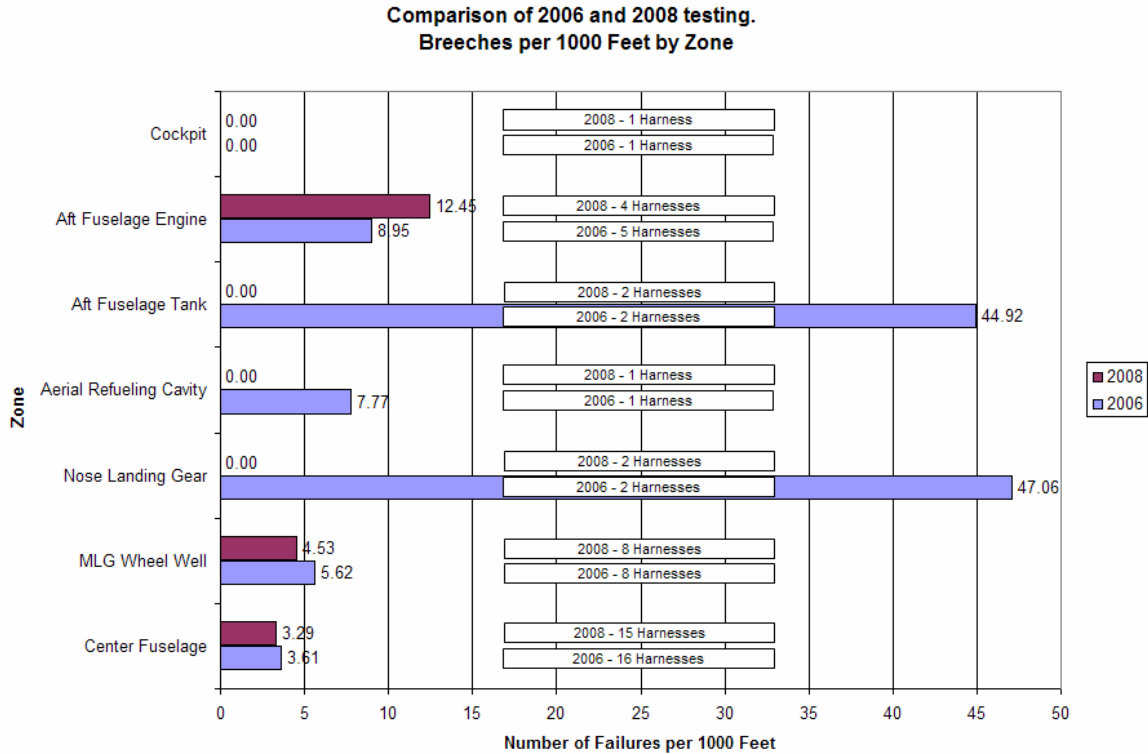
Figure 3. Comparison of DelTest 2006 and 2008. Breeches per 1000 Feet reported by zone.

The greatest variation seen between the 2006 and 2008 testing was in the Nose Landing Gear, Aerial Refueling Cavity and Aft Fuselage Tank. No wire breaches were found in any of these harnesses, whereas failures were found in previous testing (Table 2 and Figure 3). Given the limited number of wires in these harnesses, failure of any wire would show a significantly higher rate of failure (e.g. the Nose Landing Gear zone in the 2006 tests had only two failures, but, because of only 42feet of wire in the harnesses, exceptionally high rate was found). In comparing the results of the two zones from which most of the harnesses came (the center fuselage and main landing gear wheel well), the failure rates are comparable, though in both zones, the harnesses from 2008 testing showed a reduced failure rate. The only zone to show an increase in the number

of failures was the Aft Fuselage Engine Area which showed an increase from 9.0 failures/1000ft in 2006 to 12.5 failures/1000ft.

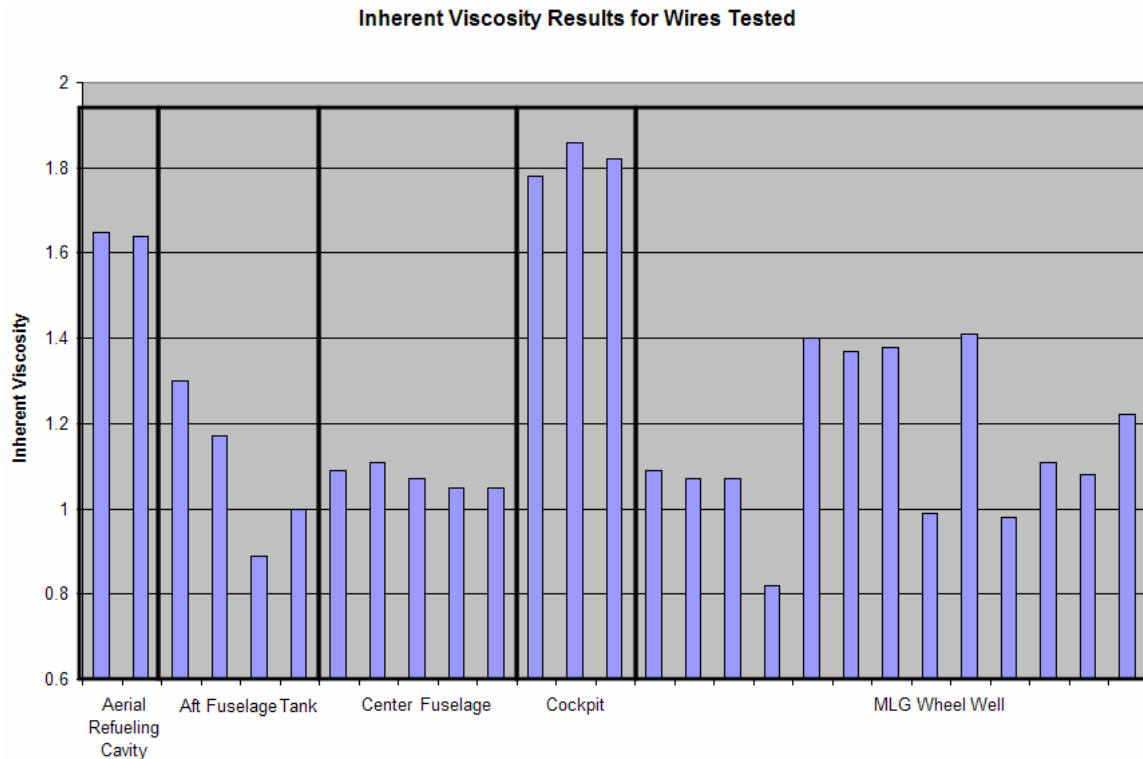
This is not unexpected, since the wheel well zone of an aircraft experiences a greater environmental exposure than other locations. The exception to this general observation is with harness 782 and one wire in harness 783.

The findings for the Central Fuselage also imply that these wires are close to the end of their lifetime.

The wires in harnesses 698 and 1523, the Aerial refueling cavity and cockpit, respectively, have values that indicate that there is not any immediate concern for these wires. The values for the cockpit are not surprising, since this zone probably experiences the least environmental challenge in the aircraft. However, this does not explain why there were relatively low values for the wires tested in 2006 from this location. There does not appear to be any trend for the wires located in the aft fuselage tank.

Figure 4. Inherent Viscosity results broken down by zone.

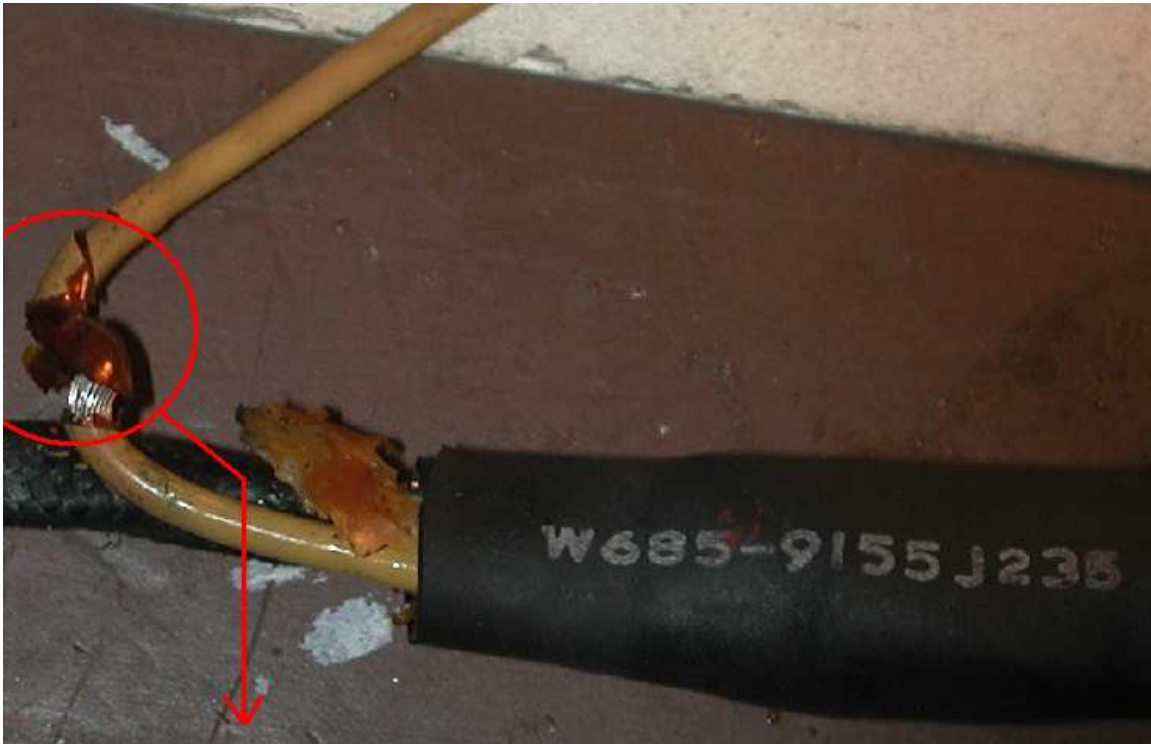
Figure C-1: Photo: Harness: H16DW685-23. Conductor exposed

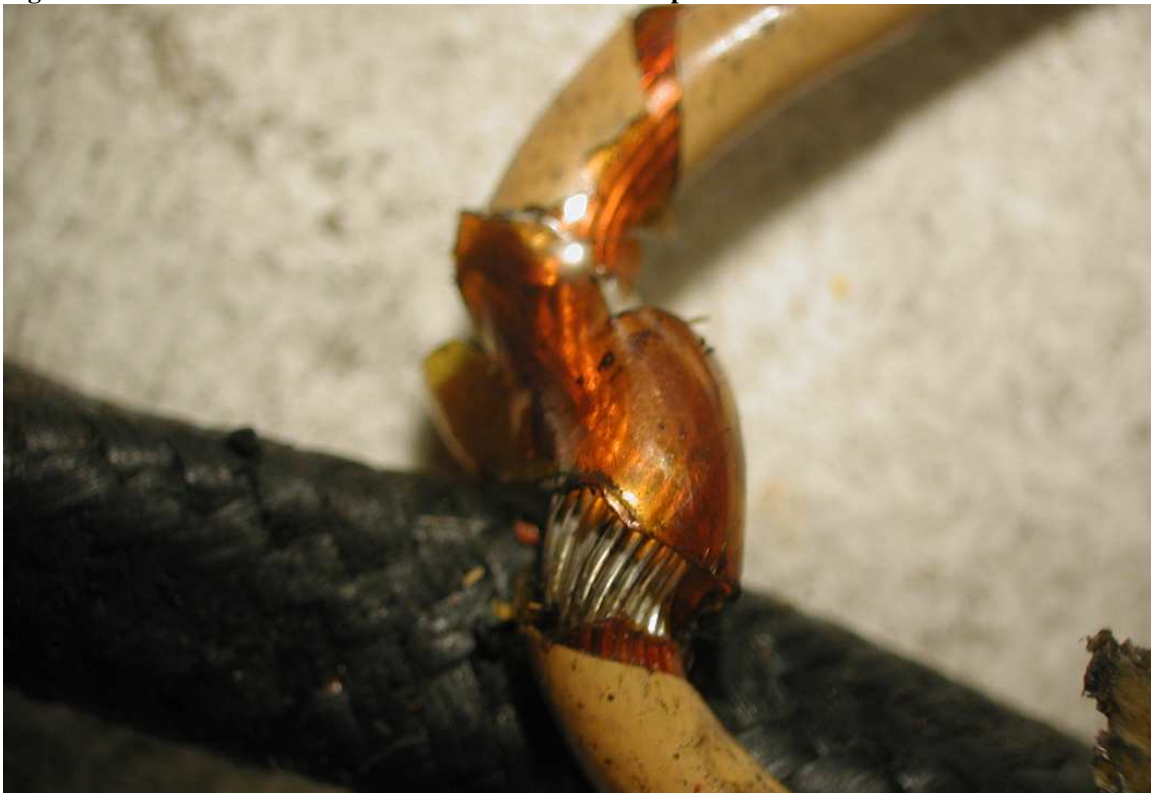
Figure C-2: Photo: Harness: H16DW685-23: Photo taken under higher magnification. Conductor exposed.

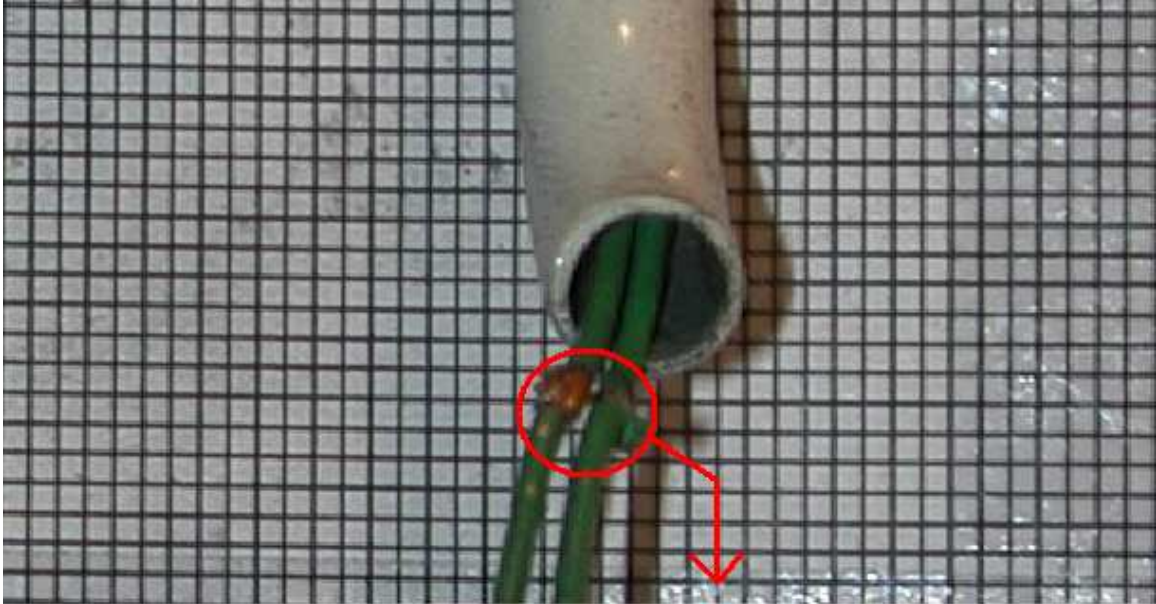
Figure C-3: Harness H16DW696-21 (a). Background grid is 1mm by 1mm. Wire 2 as seen with minimal magnification.

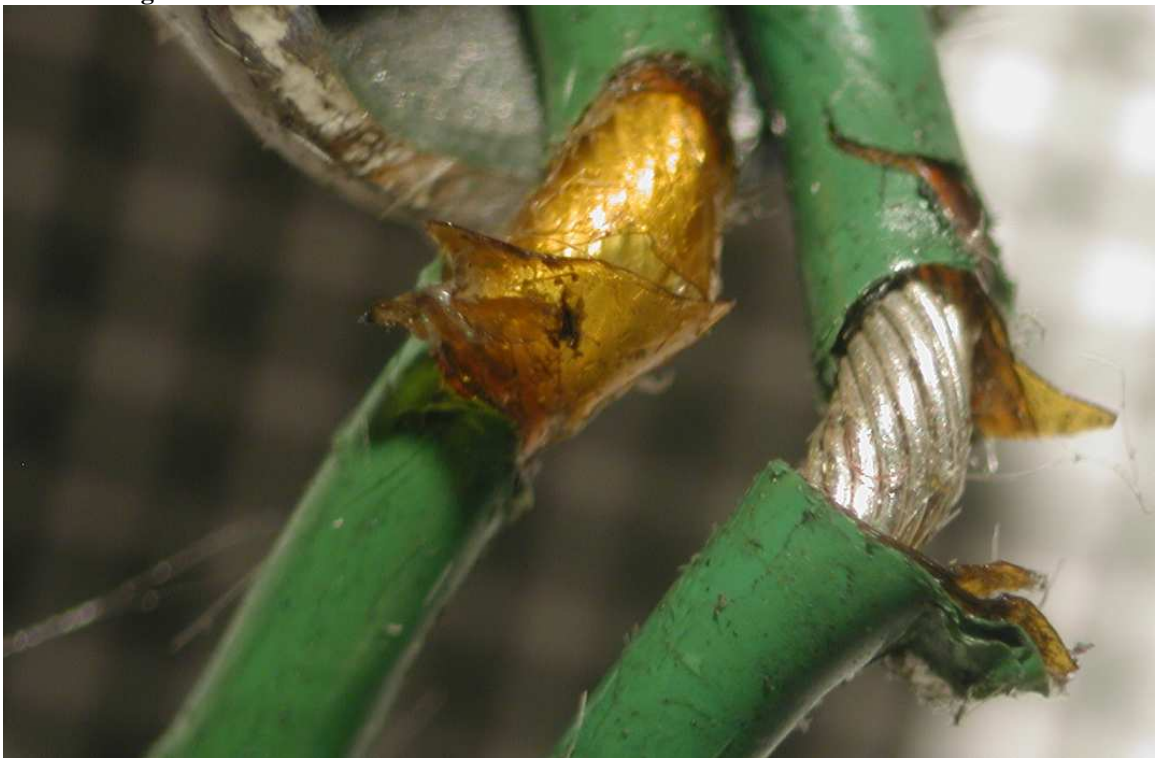
Figure C-4: Harness H16DW606-21 (a). Wire 2 has exposed conductor. Damage to the insulation of wire 1.

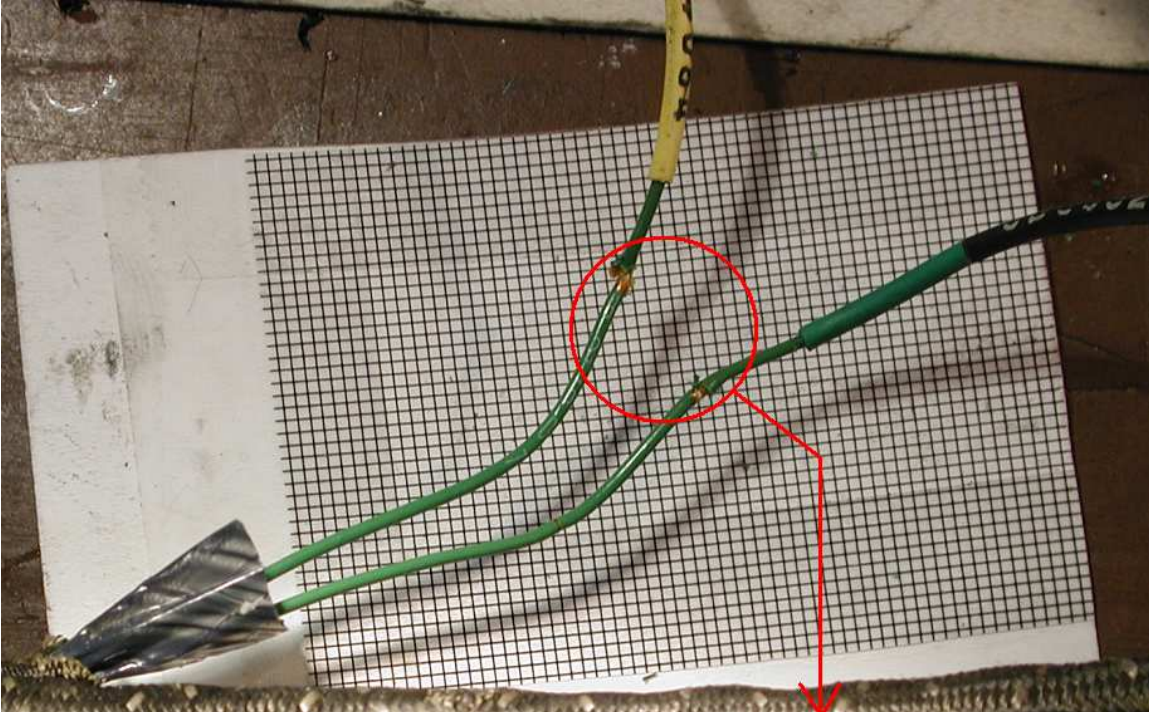
Figure C-5: H16DW651- wires 54 and 55. Background grid is 1mm long by 1mm wide. Wires 54 and 55 as seen with minimal magnification. Insulation breached to the conductor towards the GD6552 end.

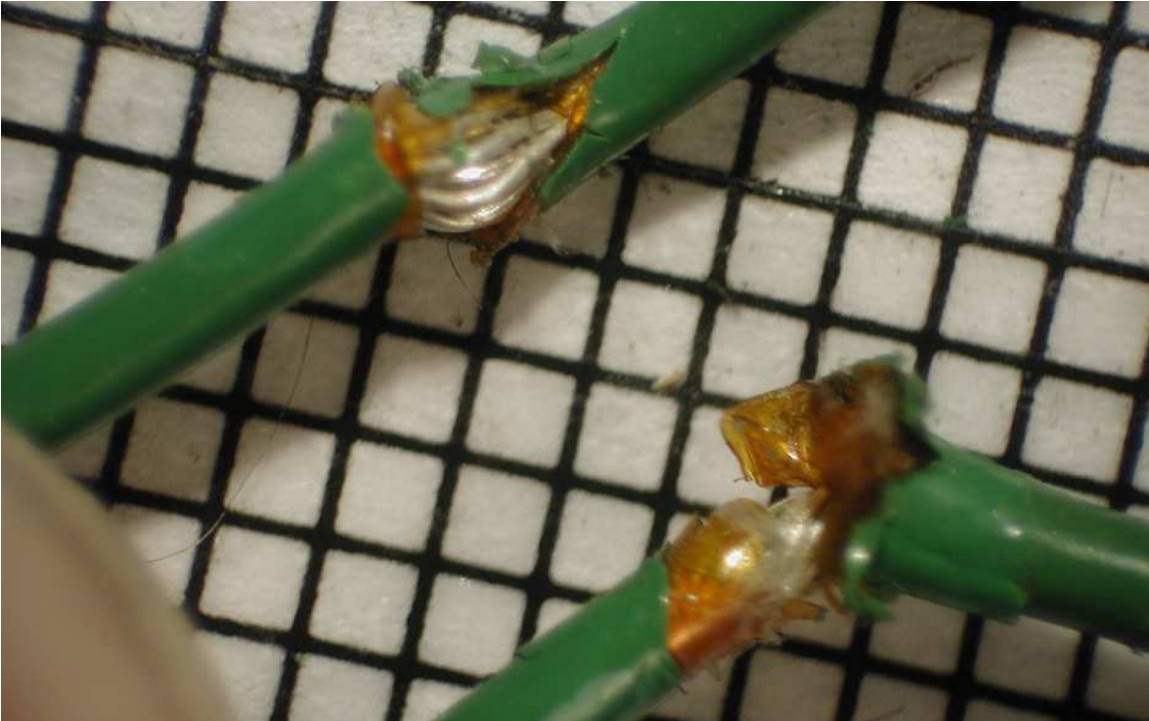
Figure C-6: Photo: H16DW651-wires 54 and 55. Background grid is 1mm long by 1mm wide. Wires 54(top) and 55(bottom) as seen under a microscope. Conductor Exposed.

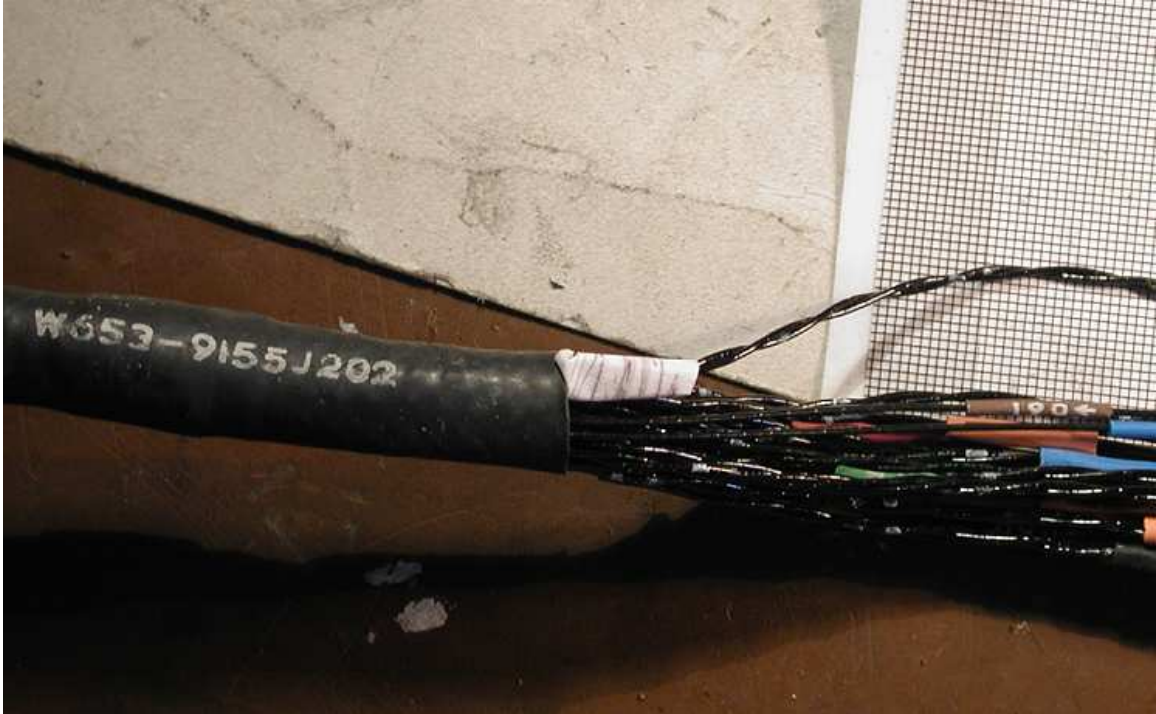
Figure C-7: Harness: H16DW653, wire224-1. Break in 24 gauge wire. Background grid scale 1mm x 1mm.

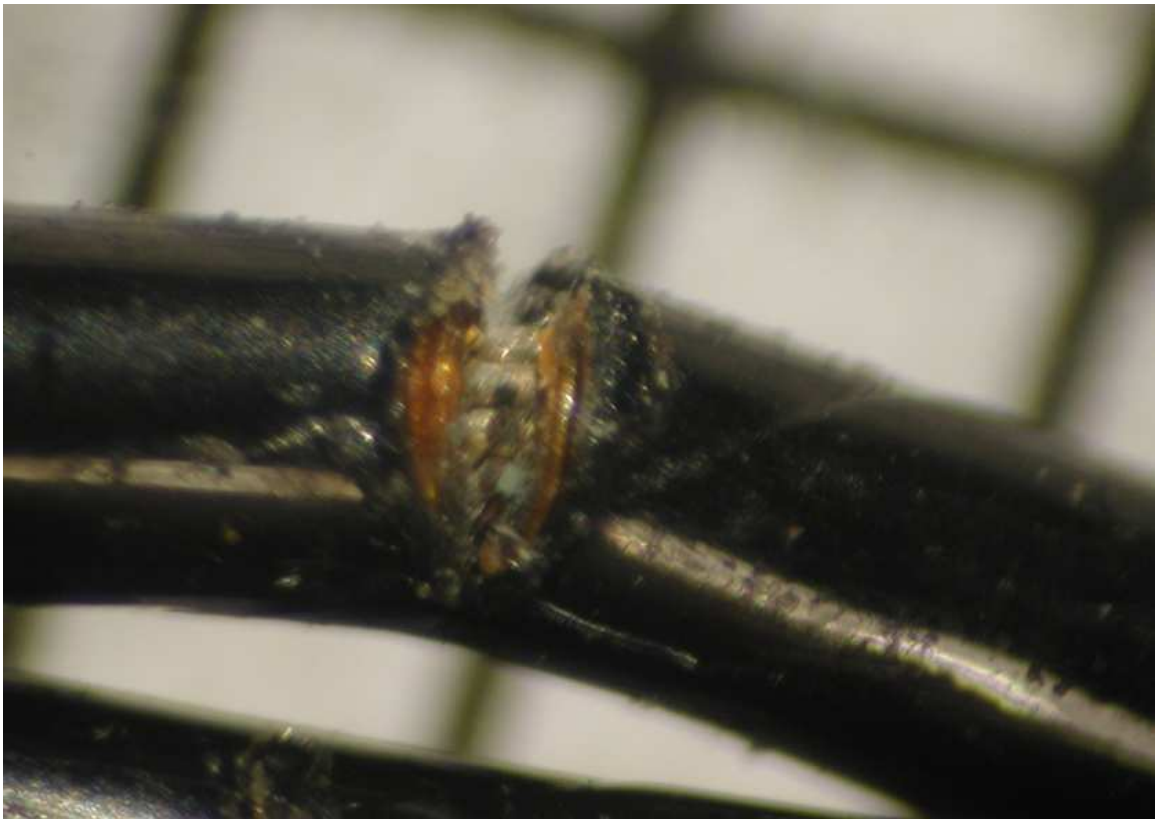
Figure C-8: Harness: H16DW653, wire224-1. Close-up photo of Figure C-7. Background grid scale 1mm x 1mm.

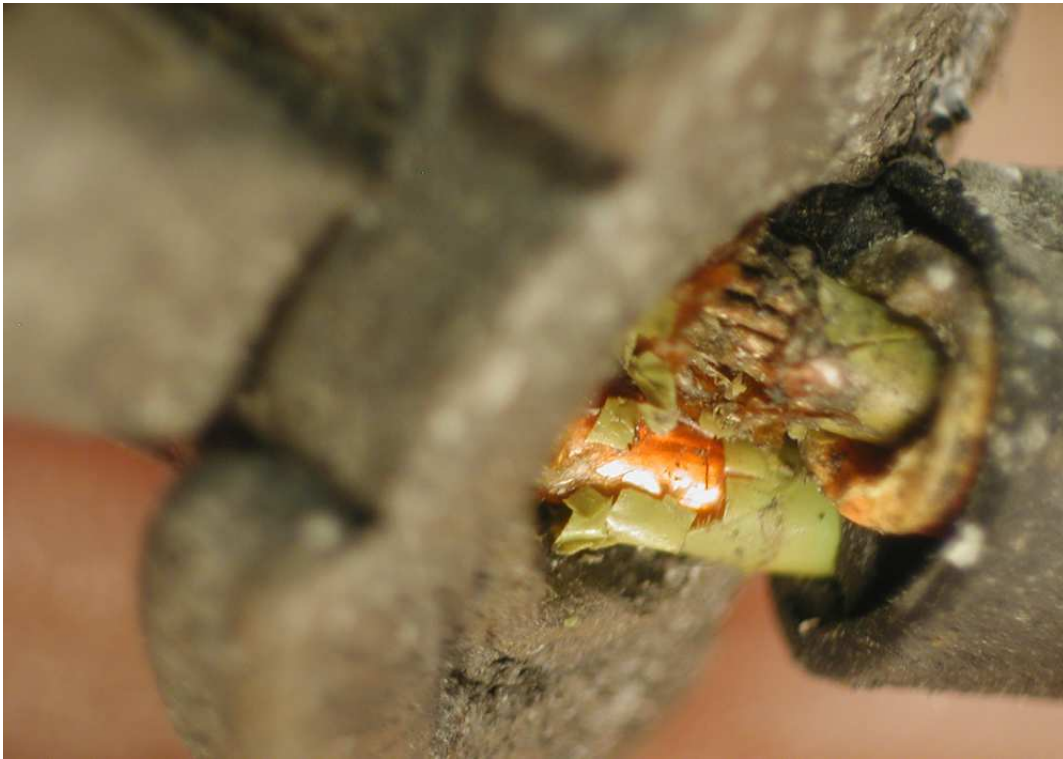
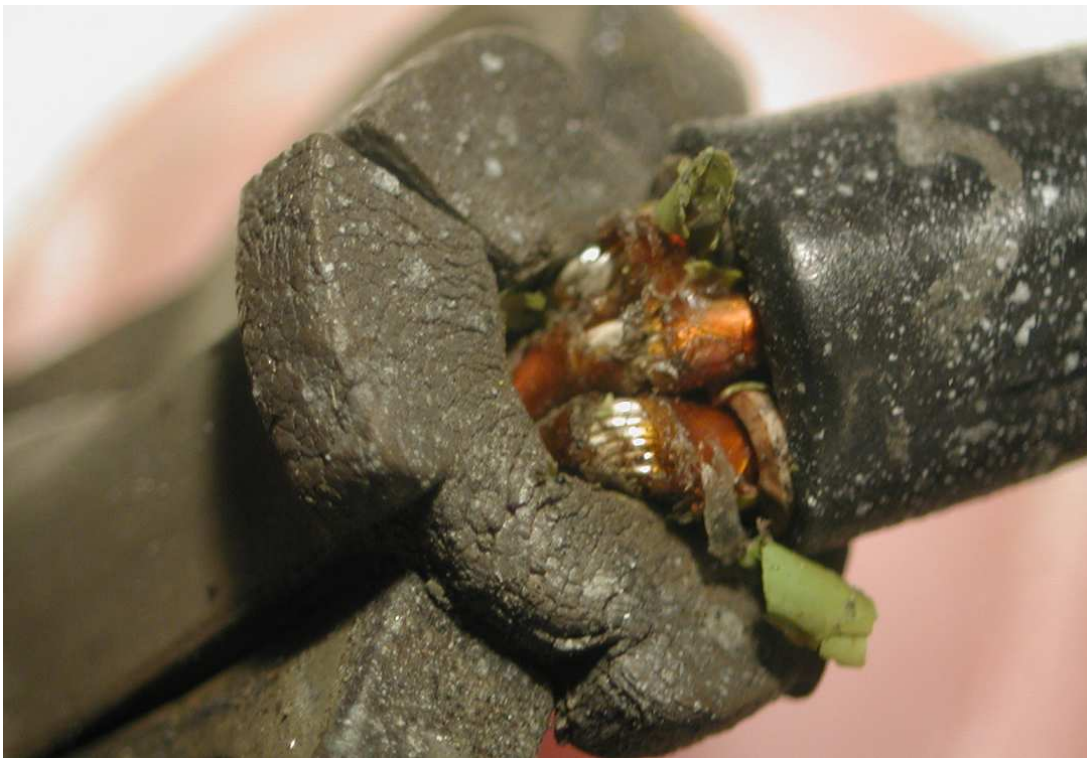
Figure C-9: Harness: H16DW693-21. Wires coming out of a conduit with multiple breaches to conductor.

Figure C-10: Harness: H16DW693-21. Same as Figure C-9.

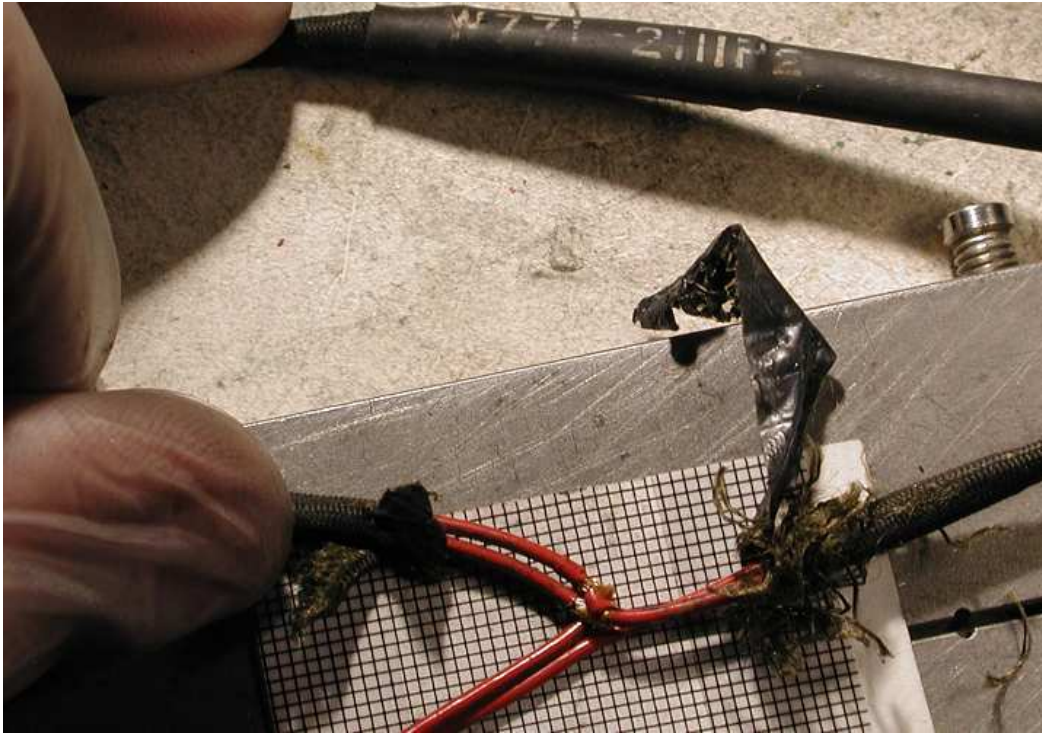
Figure C-11. Harness H16DW771, wire numbers 15 and 16. Insulation breach found at break intersection with wire bundle. Background grid scale 1mm x 1mm.

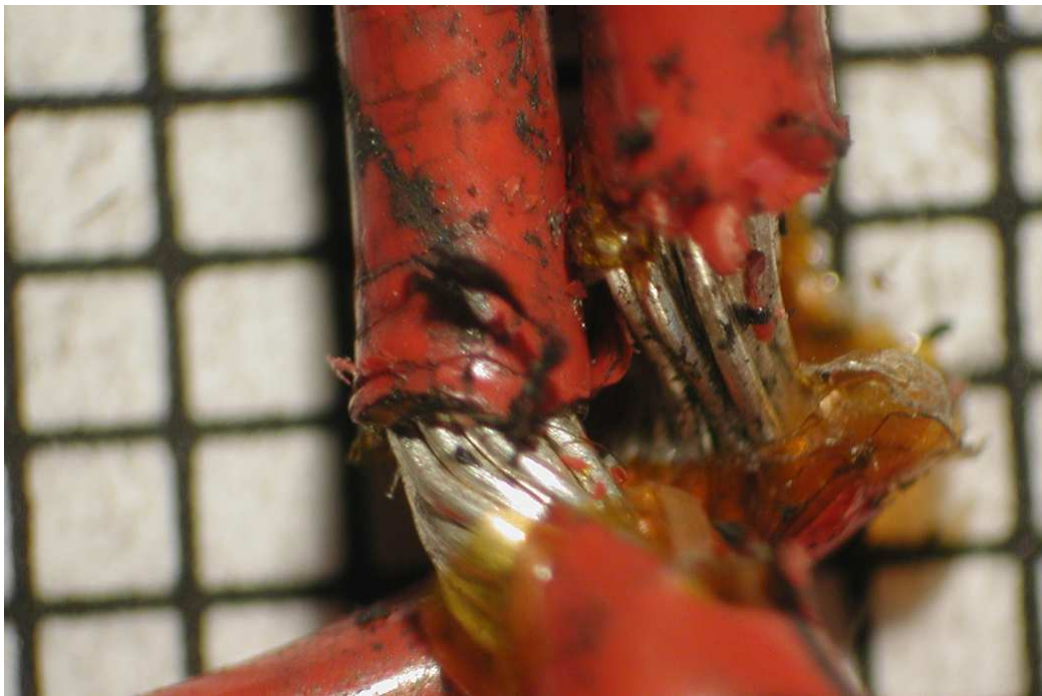
Figure C-12. Harness H16DW771, wire numbers 15 and 16. Close-up photo of Figure C-11. Background grid scale 1mm x 1mm.
