# The Wonderful World of Wiring

**Kapton Wire, TKT, Aircraft Rewire & Refurbishment**

A publication of InterConnect Wiring.

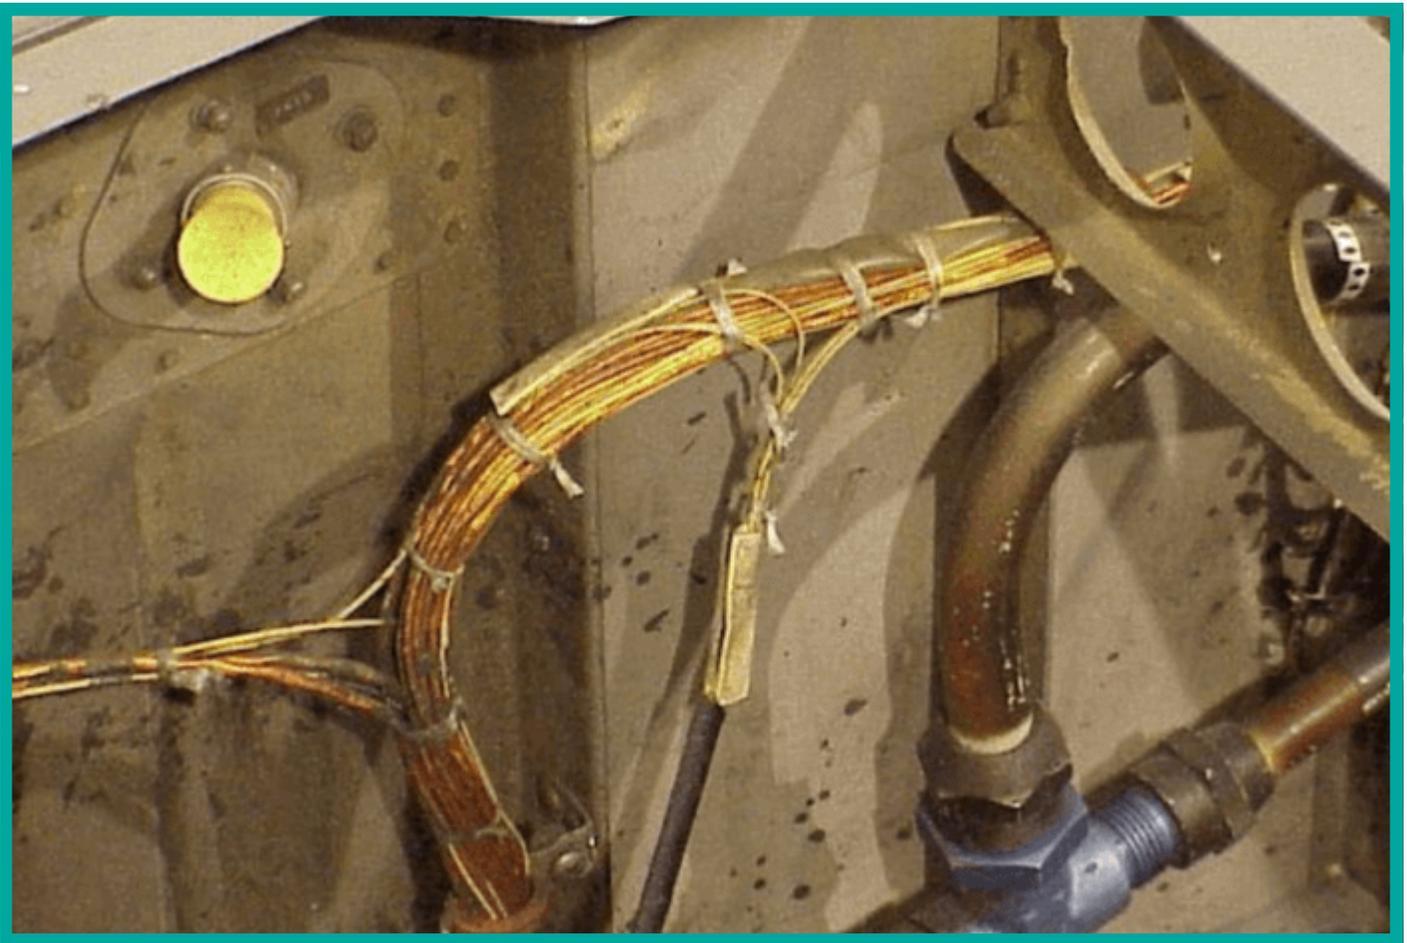
Below is a photo of a harness bundle with Kapton wires that InterConnect removed from a UH-60A for the Army National Guard Rewire Program. This old wiring harness would later be replaced with a new harness bundle manufactured by InterConnect using TKT insulated wire.

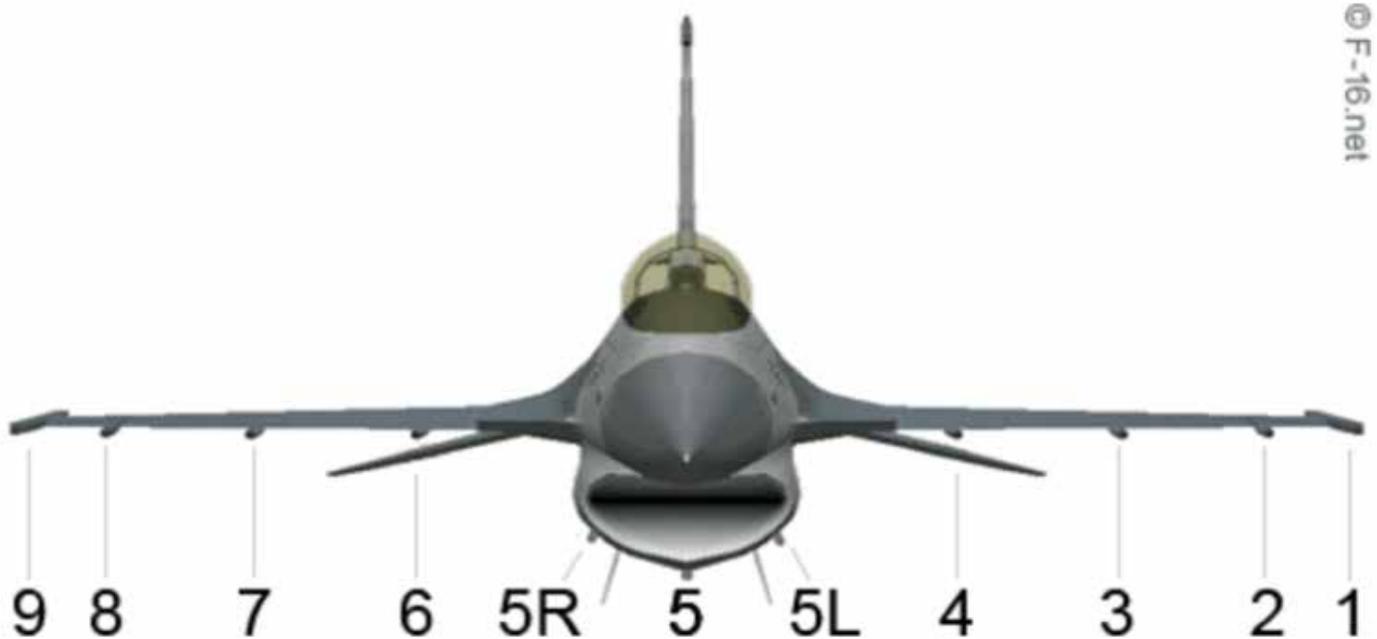
On the F-16 aircraft there are nine wing weapon stations. A wing weapon station is an attachment point for an ordnance such as a bomb, missile, or rocket. Wing stations can also carry reconnaissance pods, cameras, fuel tanks, or storage containers. Station 1 is on the tip of the left wing. Station 2, 3, and 4 are all on the left wing. Stations 6, 7, 8, and 9 are on the right wing with Station 9 being the right wing tip. Station 5 is on centerline of the fuselage. The figure below shows the wing weapon stations.

So now that we know what a wing weapon station is, what is a Station 5 wiring harness? A Station 5 wiring harness is the wiring harness inside the F-16 fuselage that directly attaches to the pylon at Station 5. For Block 40 and earlier F-16's the Station 5 is the largest wiring harness in the F-16. Typically its part number is HI6DW2602. Besides attaching to the Station 5 pylon it also stretches across the fuselage and connects to the "attach areas" of both wings.

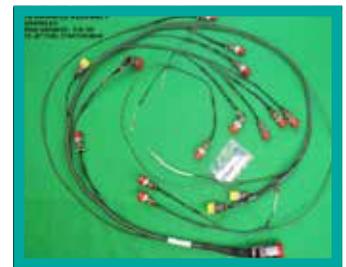
FIGURE 2

Normally, F-16 wiring harnesses have a Nomex braid that protects the wires underneath. Figure 2 shows a typical F-16 wiring harness with Nomex braid. The engineers who first designed the F-16 did not want to submerge a Nomex braided wiring harness in jet fuel; therefore, instead, they designed convoluted tubing wiring harnesses.

The convoluted tubing wiring harness was a good design, but as stated earlier, after the first ~2,000 F-16s a design change was made. Instead of convoluted tubing wiring harnesses, the F-16 engineers changed the design to injection molded wiring harnesses. Later model F-16s, including the ones currently being manufactured, are all injection molded wiring harnesses for the fuel cell area.

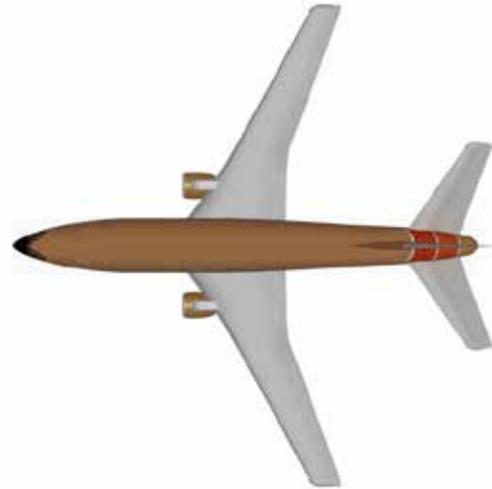
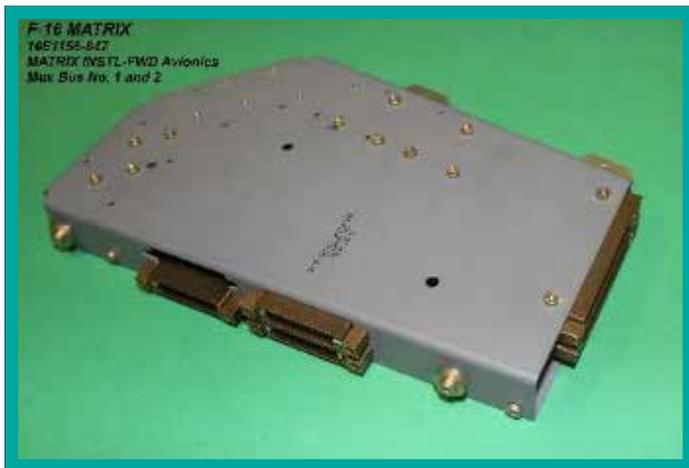
An airplane is typically made up of four main structural components: (1) the fuselage, (2) the wings, (3) the horizontal tail, and (4) the vertical tail. The word fuselage is derived from the French word fuselé which means “spindle-shaped”. The fuselage is the largest structure in the F-16 as well as most other aircraft. It contains the crew, passengers, cargo, equipment (such as multiplex or mux panels), bulkheads, and my favorite ‘wiring’. The figure to the right (colored brown) displays the fuselage for a Boeing 737 aircraft.

The next portion of our F-16 Fighter Jet Design Class 101 is, “What is multiplex?” Multiplex is a way of sending multiple signals or streams of information over a communications system at the same time in the form of a single, complex signal. The signal is composed of either highs or lows (also called 1’s or 0’s). The F-16 uses multiplex signals in four primary systems: (1) navigation, (2) flight control, (3) communication, and (4) weapons. Multiplex signals are sent throughout the F-16 using a special type of wire called a ‘mux wire’. If there is a long length of mux wire, the multiplex signal starts to lose its strength. To fix this problem, mux transformers are used throughout the F-16 to enhance the signal strength. The mux transformers are contained in metal boxes called Mux Panels. In the F-16, Mux Panels are located in two structures: (1) the wings and (2) the fuselage. Thus, fuselage Mux Panels are boxes that contain mux transformers spread throughout the fuselage. Typically for an F-16 there are 18 fuselage Mux Panels and 6 wing Mux Panels. A typical fuselage Mux Panel is shown above. The mux transformers are located inside the metal box.

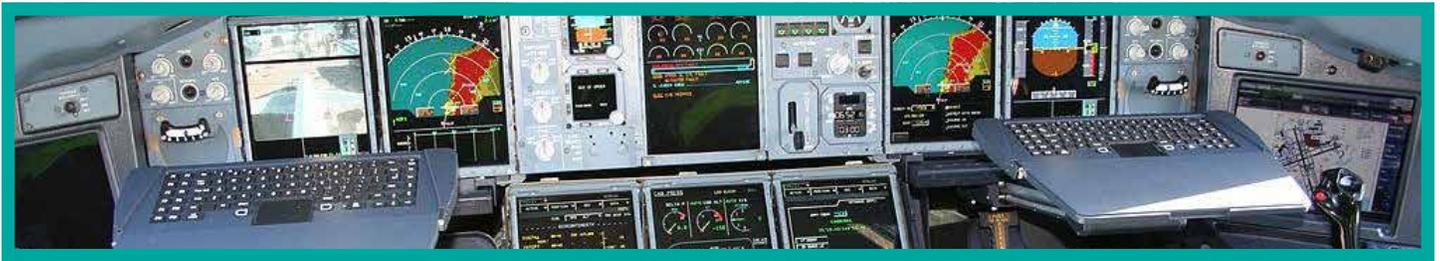
A glass cockpit works similarly to your cell phone or tablet. A pilot changes screens as needed during flight using his finger. The glass cockpit replaces cockpit panels. So now you know what a “Glass Cockpit” is. Above is a photo of an Airbus A380 glass cockpit. As you can see, it has multiple large screens that do the same operations that cockpit panels used to do. □

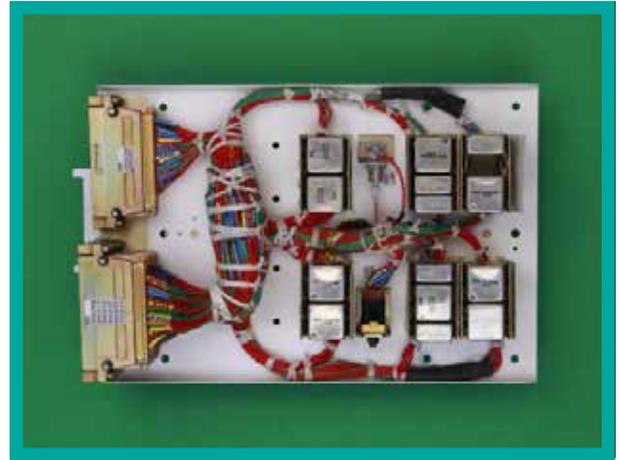
There are 4 main types of electrical panels in an F-16: (1) Cockpit, (2) Power or Circuit Breaker, (3) Multiplex (Mux), and (4) Relay. InterConnect refurbishes each of these types of electrical panels. We have been doing this now for over 25 years. Almost every day an F-16 electrical panel arrives for repair or refurbishment. InterConnect receives F-16 electrical panels from all over the world. Currently there are 25 countries who fly the F-16. Each one of these countries has one thing in common: "At some point they will all need to get their F-16 electrical panels refurbished". Of electrical panels, the most complex one is the relay panel. The figure shows a typical F-16 relay panel.

The reason F-16 relay panels are so complex is that they have so many electrical circuits inside them. A relay panel is made up of: (1) relays (of course), (2) wire, (3) tons of splices, (4) sheet metal, and (5) connectors. A typical F-16 relay panel may have 10 to 20 relays as well as over 50 splices. When energized, each relay opens many new electrical circuits.

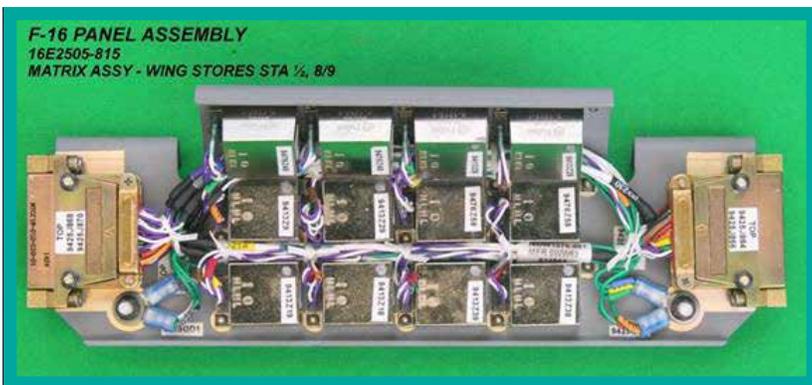
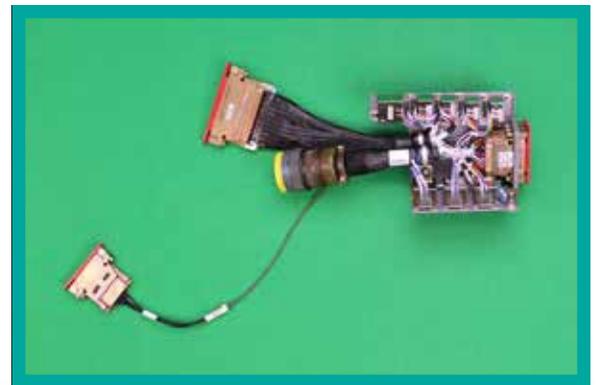
The basic components of a wing mux panel are: (1) sheet metal which serves as the enclosure, (2) mux transformers, (3) connectors, (4) wires, and (5) splices. See the two figures below for sample mux panels. Although InterConnect is happy to make spare mux panels, it is less expensive to refurbish them instead of making new ones. The main cost drivers for wing mux panels are the mux transformers and the sheet metal. InterConnect has found, over our 25-year history, that there have been only a few times that the mux panel needed new sheet metal. Thus, when InterConnect refurbishes wing mux panels the main costs are the mux transformers instead of the expensive sheet metal.

Refurbishing F-16 wing mux panels is a fairly simple process. InterConnect's process is: (1) remove and discard the old mux transformers, connectors, wire, and splices, (2) install the new component parts, and (3) electrically test the refurbished mux panel.

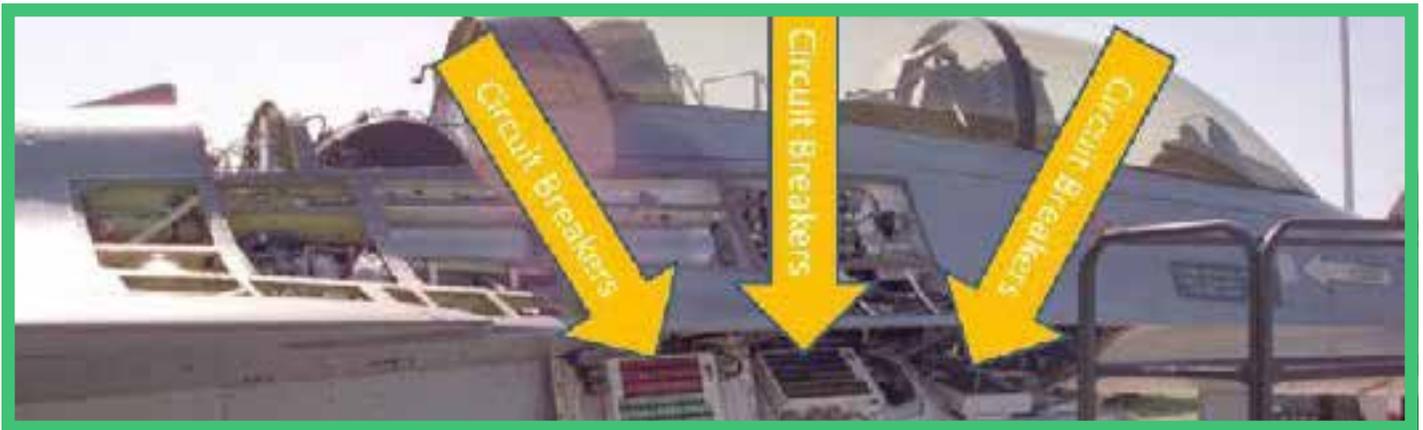
If this blog was written by the president of InterConnect Wiring, John Ashour, he would say that the circuit breaker panels inside an F-16 are in Station 5, Station X, Station Blah, etc., but for me, I am not that smart! I am a very visual person who didn't write the Lockheed Martin specification 16PR8817, like John did, so find below a basic picture of where the circuit breakers are located inside of this fighter jet.
