# F-16 Wiring Harness Training – Advanced eBook

By John Ashour

InterConnect Wiring

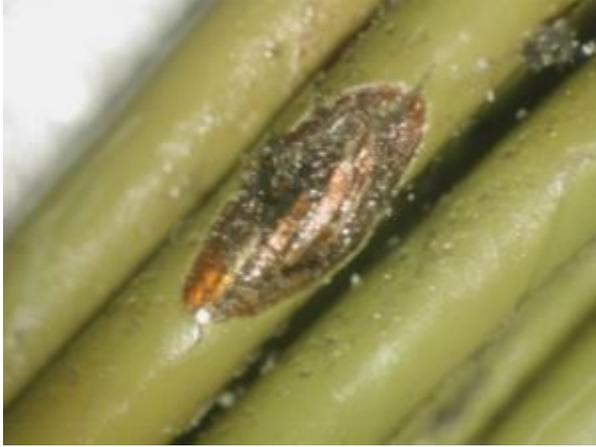
A breach in the insulation of a wire is when the insulation no longer covers the conductor. Figure 1 shows a breach in F-16 Kapton wire. This breach was probably caused by chaffing of the wire against an object.

*Figure 1 Breached F-16 Kapton Wire*

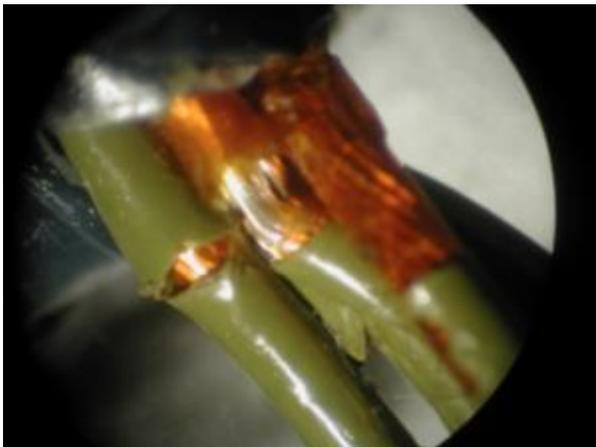
Figure 2 shows more F-16 wires that are breached. Older F-16's were made with Kapton insulation. These older F-16's were color-coded according to a wire's gauge. The color code scheme is as follows:

1. Black: 26 gauge
2. Green: 22 gauge
3. Red: 20 gauge
4. White: 18 gauge
5. Yellow: 12 gauge

The green color shown in Figure 2 represents 22-gauge wire. When you look at these wires you see: (a) green, which is the paint for the color code, (b) orange, which is the Kapton insulation, and (c) silver, which is the conductor of the wire. The wire on the far left has a small breach that you can see because the silver conductor is apparent. The middle wire has a large breach. The green paint is breached as well as the orange Kapton insulation leaving the silver conductor exposed. The wire on the far right is not breached to the conductor. The green paint is breached but the Kapton insulation is not.

*Figure 2 Multiple F-16 Wires Breached*

The breaches observed in Figure 2 were probably caused by bending of the wires around an object. Because there are two wires adjacent to each other this breach is worse than others. When there are two or more breaches next to each other there is a chance of a short circuit which can lead to intermittent signals, arcing, and fires.

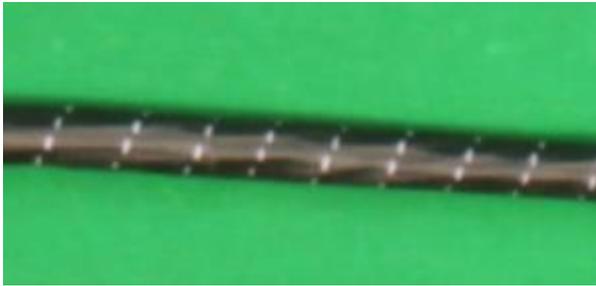
Actuators are attached to the light control surfaces to move them in flight. Actuators receive electrical signals (instead of cables and pulleys). The electrical signals are sent from computers (and the pilot) via electrical wiring harnesses. Thus, the wiring harnesses are important and play a huge role in the safety of the aircraft. The wiring harnesses that contain these electrical signals are called “Flight Control Wiring Harnesses”. When working on the F-16, maintainers can easily see which wiring harnesses are flight control because they have a double white tracer in the olive-drab Nomex braid. Figures 4 and 5 show a “non-flight control” and a “flight control” wiring harness, respectively.

Figure 4 Non-Flight Control F-16 Wiring Harness

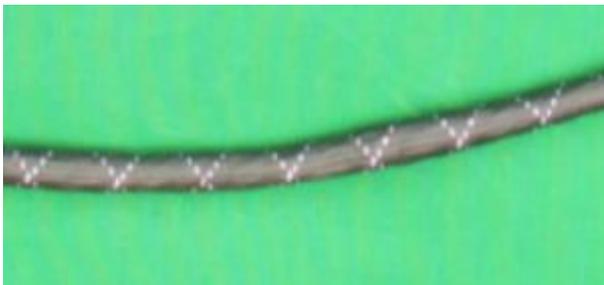
Figure 5 Flight Control F-16 Wiring Harness

Flight control wiring harnesses are installed throughout the F-16. Table 7 shows where they are generally located throughout the aircraft. The F-16 was designed with quadruple redundancy of its flight control systems. The four flight control systems are identified as A, B, C, and D. Each system sends and receives signals to computers that compare inputs and decides how to maneuver the aircraft. There are separate wiring harnesses for each of the four redundant systems throughout the aircraft. Additionally, each flight control wiring harness is installed away from the other flight control wiring harnesses to make sure that if one experiences a problem (such as bullets from small arms fire), then it will not affect the other flight control wiring harnesses.
