## F-16 Wiring Harness Training – Advanced eBook

By John Ashour

InterConnect Wiring

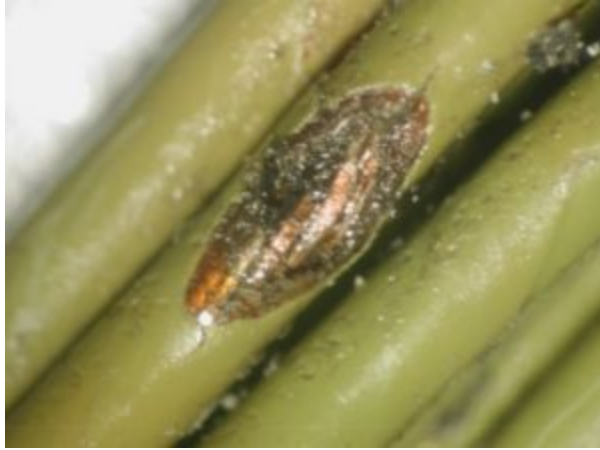
A breach in the insulation of a wire is when the insulation no longer covers the conductor. Figure 1 shows a breach in F-16 Kapton wire. This breach was probably caused by chaffing of the wire against an object.

*Figure 1 Breached F-16 Kapton Wire*

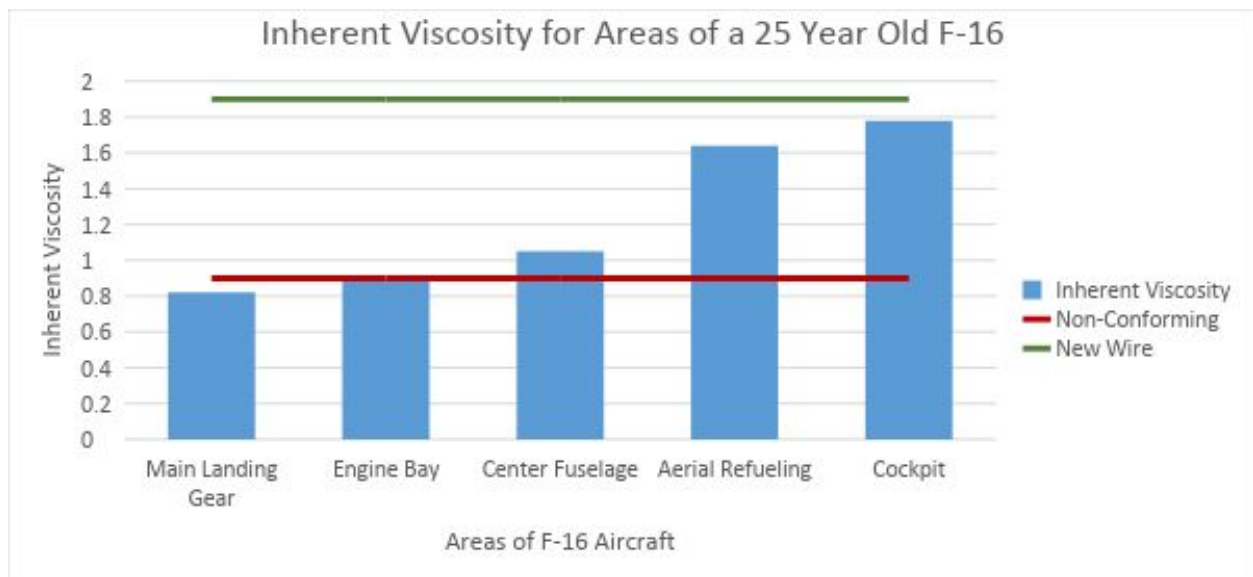
Since 2006, InterConnect has sent old F-16 wiring harnesses to a professional laboratory to have inherent viscosity measured. In order to measure it, the laboratory must conduct a destructive test on the Kapton insulation. As one would expect, inherent viscosity of the Kapton wire varies throughout the F-16 due to the environment (i.e. where the F-16 wiring harness is installed). In some areas, the Kapton is like new. In other areas it has seriously degraded. Table 2 shows the results (i.e. the lowest values found in each area tested) of laboratory studies of F-16 Kapton wiring. Notice that it varies depending on the where the wiring harness is installed.

Figure 3 Inherent Viscosity for Areas of a 25-Year-Old F-16

The bottom line of the laboratory results is that when aged, the Kapton wiring has degraded beyond the recommended cutoff value of 0.9, the Kapton is a safety of flight issue, and the wiring should be replaced.

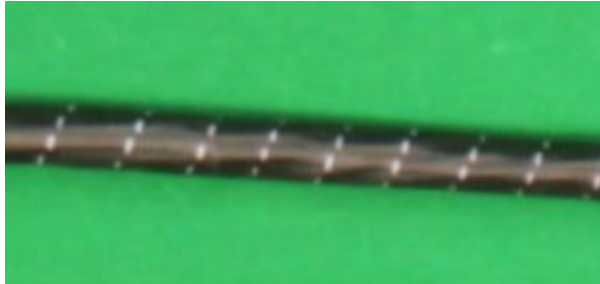
and (5) speed brakes. Each of these structures move during flight and thus control the F-16. Actuators are attached to the light control surfaces to move them in flight. Actuators receive electrical signals (instead of cables and pulleys). The electrical signals are sent from computers (and the pilot) via electrical wiring harnesses. Thus, the wiring harnesses are important and play a huge role in the safety of the aircraft. The wiring harnesses that contain these electrical signals are called “Flight Control Wiring Harnesses”. When working on the F-16, maintainers can easily see which wiring harnesses are flight control because they have a double white tracer in the olive-drab Nomex braid. Figures 4 and 5 show a “non-flight control” and a “flight control” wiring harness, respectively.

*Figure 4 Non-Flight Control F-16 Wiring Harness*
