# F-16 Wiring Harness Training – Advanced eBook

By John Ashour

InterConnect Wiring

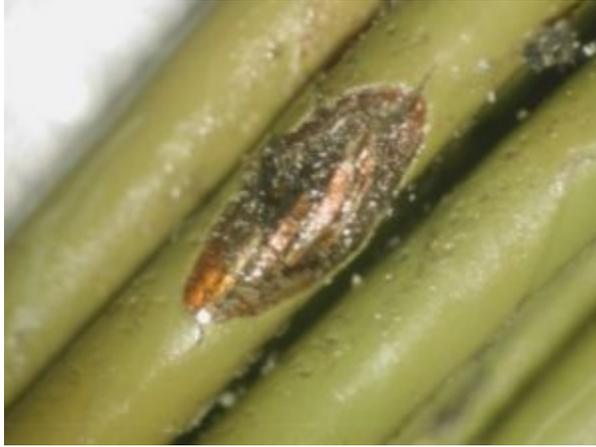
A breach in the insulation of a wire is when the insulation no longer covers the conductor. Figure 1 shows a breach in F-16 Kapton wire. This breach was probably caused by chaffing of the wire against an object.

*Figure 1 Breached F-16 Kapton Wire*

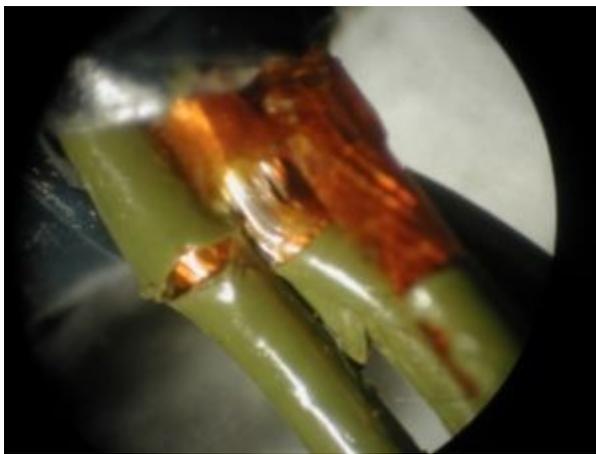
The green color shown in Figure 2 represents 22-gauge wire. When you look at these wires you see: (a) green, which is the paint for the color code, (b) orange, which is the Kapton insulation, and (c) silver, which is the conductor of the wire. The wire on the far left has a small breach that you can see because the silver conductor is apparent. The middle wire has a large breach. The green paint is breached as well as the orange Kapton insulation leaving the silver conductor exposed. The wire on the far right is not breached to the conductor. The green paint is breached but the Kapton insulation is not.

Figure 2 Multiple F-16 Wires Breached

The breaches observed in Figure 2 were probably caused by bending of the wires around an object.

Because there are two wires adjacent to each other this breach is worse than others. When there are two or more breaches next to each other there is a chance of a short circuit which can lead to intermittent signals, arcing, and fires.

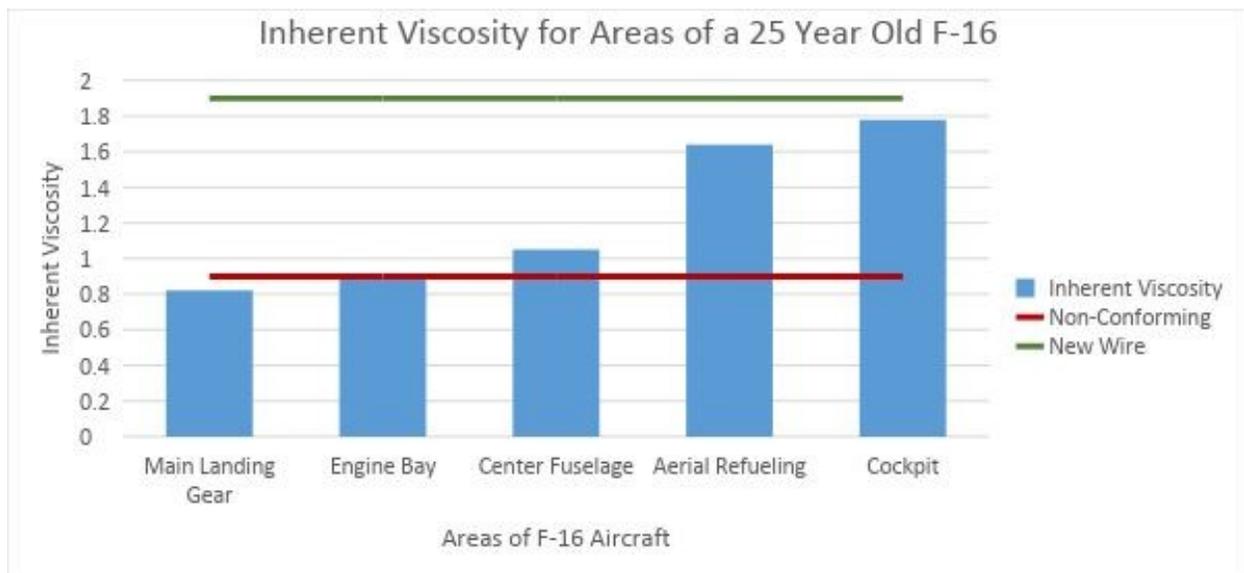
Since 2006, InterConnect has sent old F-16 wiring harnesses to a professional laboratory to have inherent viscosity measured. In order to measure it, the laboratory must conduct a destructive test on the Kapton insulation. As one would expect, inherent viscosity of the Kapton wire varies throughout the F-16 due to the environment (i.e. where the F-16 wiring harness is installed). In some areas, the Kapton is like new. In other areas it has seriously degraded. Table 2 shows the results (i.e. the lowest values found in each area tested) of laboratory studies of F-16 Kapton wiring. Notice that it varies depending on the where the wiring harness is installed.

Figure 3 Inherent Viscosity for Areas of a 25-Year-Old F-16

The bottom line of the laboratory results is that when aged, the Kapton wiring has degraded beyond the recommended cutoff value of 0.9, the Kapton is a safety of flight issue, and the wiring should be replaced.

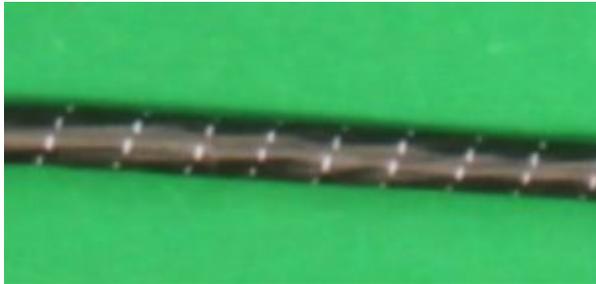
and (5) speed brakes. Each of these structures move during flight and thus control the F-16. Actuators are attached to the light control surfaces to move them in flight. Actuators receive electrical signals (instead of cables and pulleys). The electrical signals are sent from computers (and the pilot) via electrical wiring harnesses. Thus, the wiring harnesses are important and play a huge role in the safety of the aircraft. The wiring harnesses that contain these electrical signals are called "Flight Control Wiring Harnesses". When working on the F-16, maintainers can easily see which wiring harnesses are flight control because they have a double white tracer in the olive-drab Nomex braid. Figures 4 and 5 show a "non-flight control" and a "flight control" wiring harness, respectively.

*Figure 4 Non-Flight Control F-16 Wiring Harness*

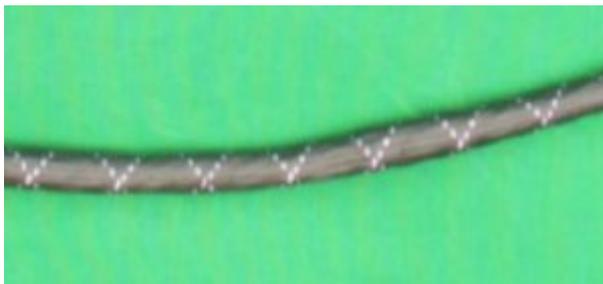
*Figure 5 Flight Control F-16 Wiring Harness*
